Acoustic monitoring of a prestressed concrete beam reinforced by adhesively bonded composite

1 DESCRIPTION OF THE PROJECT “CLERVAL”

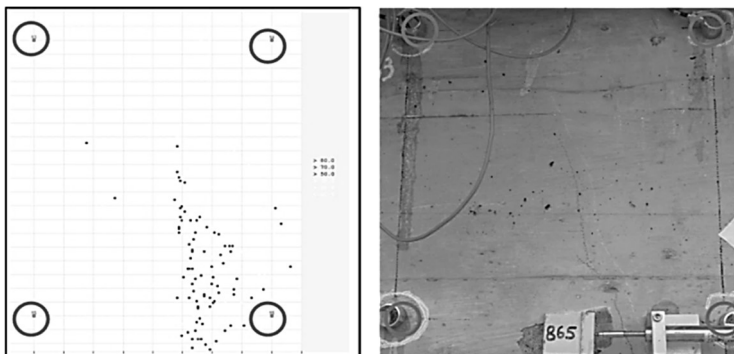
Figure 5. Comparison of 2D localization of events and the visual crack identification after the test at S4 section during initial flexure tests

In the case of flexural tests, the localized acoustic emission system was mainly aimed at identifying the crack propagation in pre-determined cracked areas (sections S2 and S4). Though, from calculation, during flexural test before reinforcement, crack propagation should have occurred first in section S2, it was proved that it actually started in section S4. This was detected both from acoustic emission, crack opening sensor and strain gage measurements. It was checked that the localization of acoustic events was similar to the visual crack identification made after the initial flexural test (Figure 5).

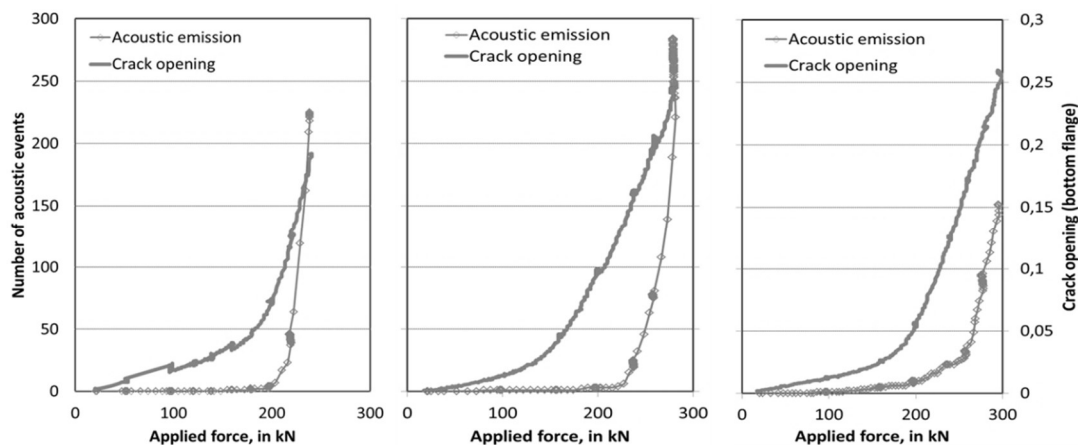
Figure 6. Number of acoustic events and measured crack opening in function of the applied force before reinforcement, after first flexural reinforcement and after final flexural reinforcement at section S4

Besides, for the three flexural phases, acoustic emission data was compared with crack opening measures (Figure 6). It can be seen that both are not always correlated. Acoustic emission allows following crack propagation, though crack opening measure may not induce crack propagation. It can also be seen that the reinforcement has slightly delayed the onset of crack propagation. Acoustic emission technique seems thus to be a good indicator to check the activity of a crack on-site and to detect the crack tip localization. It may also be used to assess the quality of reinforcement or repair.

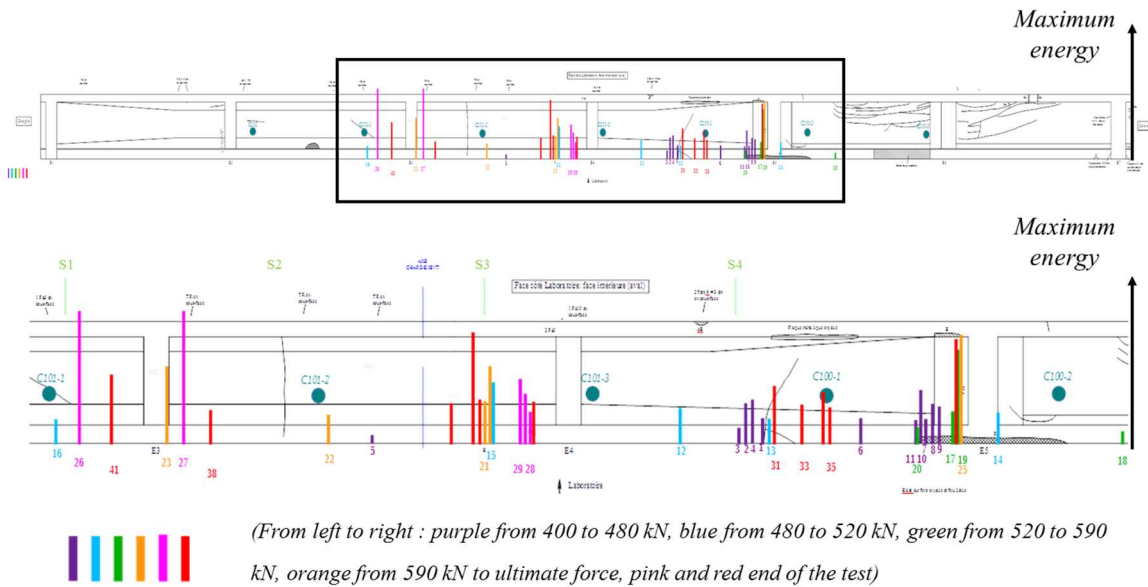
Figure 7. 1D acoustic events along the beam during flexure test

All the 1D localized events with the corresponding energy have been reported on figure 7. First events were detected from 400 kN to 480 kN in section S4 and in a section where corrosion was detected before the realization of the test. It seems that the encountered failures of prestressing steel wires induced a strong change in the behavior of the beam. Then, several prestressing steel wires broke before the final failure that occurred at 615 kN (composite peeling-off in section S2). Acoustic survey allowed with the other monitoring devices to determine the failure process. All the detected acoustic events seem in that case to be attributed to prestressing steel wires failures (when composite peeling-off occurred the beam was maybe too much damaged for the acoustic system to detect it).

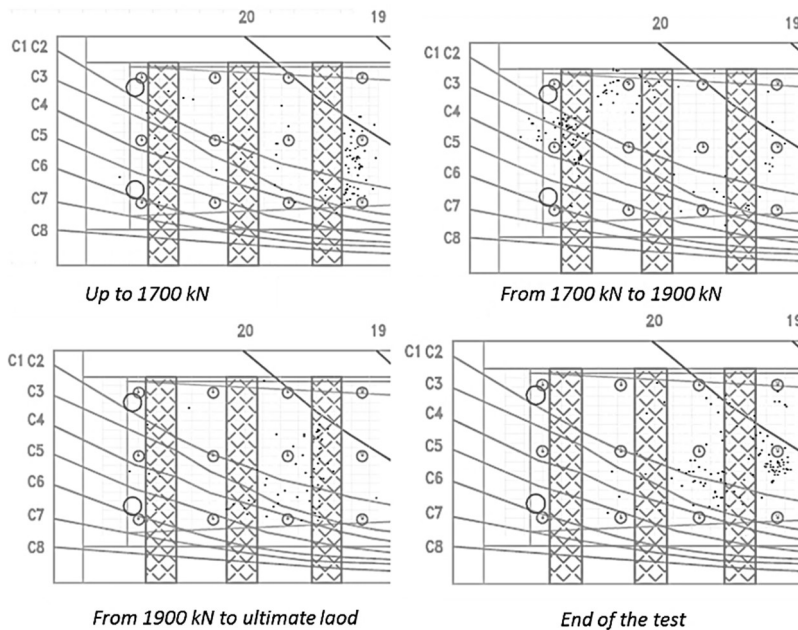
Figure 8. Localized acoustic emission events during shear test up to failure (carbon sheets and prestressing cables are visualized)

The localized acoustic emission system was settled in the reinforced area between the load application and the support. It allowed localizing the acoustic events during the shear test in this area during the whole test (Figure 8). Four main periods were determined. During the first period up to 1700 kN, acoustic events mainly occurred under the load application demonstrating flexure damage rather shear damage. At the end of this period, flexural composite plates peeled-off. From 1700 kN to 1900 kN, most of acoustic events were detected in the corner close to the edge. This corresponds to a crack that was visually detected at the end of the test in this zone. From 1900 kN to the ultimate capacity (1970 kN), the acoustic emission was gain localized under the applied load. At failure, a main crack was observed under the applied load.

Though, some investigations are still under progress, acoustic emission allowed in that case identifying different failure steps during the test. The results were compared with visual inspection led during and after the test and good match was obtained. However, no particular acoustic emission could be revealed under the bonded carbon sheets indicating though high mechanical stresses have been measured on them with strain gages.

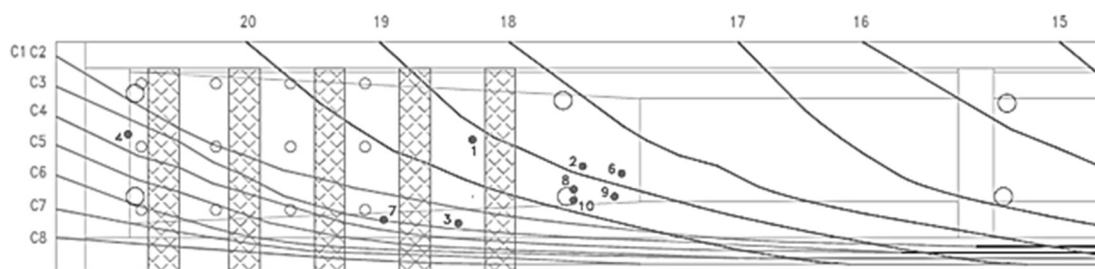
Figure 9. 2D localization of acoustic events during shear test up to failure

The detected events during the shear test have been localized in Figure 9. A similar work to the one carried out in the case of the flexure test was done here. The events 1, 2, 3, 4 and 7 proved to have too low propagation speed to be attributed to prestressing steel wire failure. They may be attributed to flexural composite peeling-off in flexure or high energy fretting. Events 6, 8, 9 and 10 may be attributed to prestressing steel wire failure. They are all localized in the same area (cable 19).
