Full scale cast iron girders reinforced with CFRP - flexural testing

ABSTRACT: This paper will report on the flexural testing of two cast iron girders from a demolished railway bridge in Scotland. The girders were 151 years old and had been reinforced with ultra high modulus carbon fibre polymer composite (CFRP) in 2004. The CFRP on one girder had been damaged during the demolition and was rendered completely ineffective before testing. The girders were 9m long and were tested in four point bending to failure giving a unique opportunity to compare the behaviour of unreinforced and reinforced cast iron at full scale. After the flexural testing fragments were tested to obtain material properties. The tests showed the considerable benefits of CFRP strengthening and confirmed that the CFRP was fully bonded to the cast iron until close to the point of failure. The test results have been compared to the original design predictions. The paper will include details of the girders, the test rig and procedure and will discuss the benefits obtained from CFRP strengthening of cast iron girders.

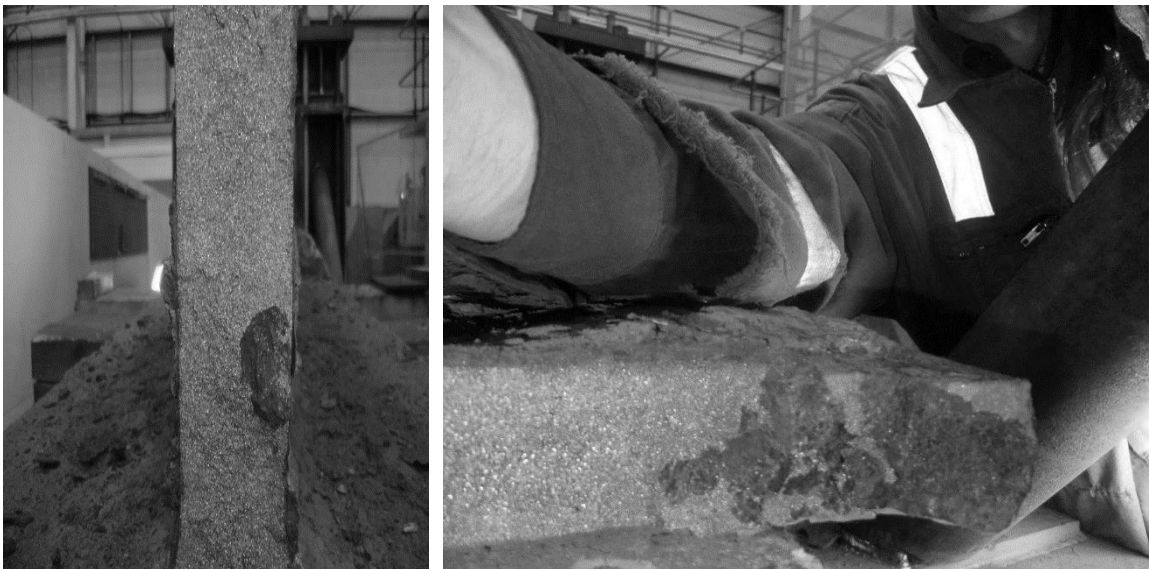
The failure of the unreinforced girder occurred over a vertical section at one end of the constant bending region where the section modulus was smallest. The failure was instantaneous, running up from the tension flange. Using calculated section properties the maximum tensile stress was 104N/mm^2 . The failure surface, shown in Figure 4, was typical of old cast iron but also contained large slag inclusions in the web and tension flange. The variations in section thickness can also be seen.

Figure 4. Failure surface of the unreinforced girder, web left, flange right. Note the inclusions.

Tensile specimens were machined from a fragment of the cast iron. The tests gave an average UTS of 143.8N/mm^2 , higher than the calculated value of 104N/mm^2 at failure of girder 1, demonstrating the deleterious effect of the slag inclusions. The average measured elastic modulus was 71.0kN/mm^2 which compares well with the value of 73.4kN/mm^2 obtained by back calculation from the flexural test readings.

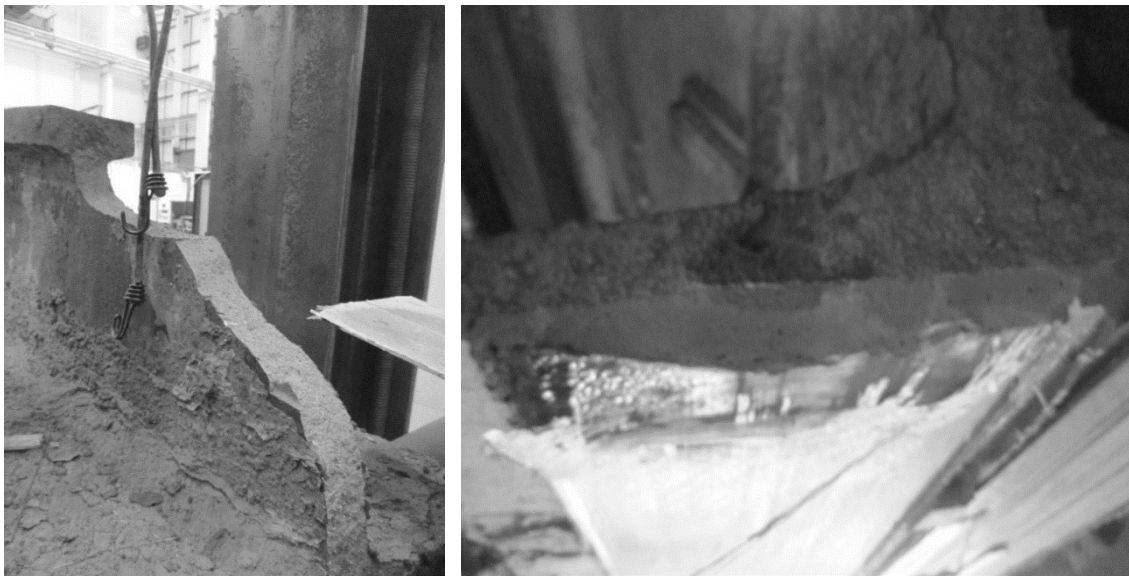
The reinforced girder behaved differently. When the jack load reached 327kN there was a sharp noise accompanied by changes in the strain readings close to midspan but complete failure did not occur. As load was increased further noises occurred. Complete, violent, failure finally occurred, the girder breaking into two large and several smaller fragments. One large piece,

weighing about 1.5 tonnes, jumped off the test rig. Examination after the test showed that the initial sharp noise was caused by the outer 4.7mm thick layer of CFRP debonding from the middle layer and rupturing at one end of the constant moment length. The subsequent noises were caused by localised debonding until at total failure the remaining 9.4mm thickness of CFRP ruptured at the failure surface accompanied by debonding of the CFRP over half the length of the girder. The failure surface ran diagonally up the girder from the tension flange, starting about 200mm outside the constant moment length and ending up just inside, as shown in Figure 5 (left). The adhesive layer at the failure surface was approximately 20mm thick and the flange thickness considerably reduced. There was also a large slag inclusion in the flange. Consultation with TGP revealed that there had been localised erosion over a short length of the cast iron from the acidic exhaust gases from steam locomotives passing under the bridge and it had been necessary to increase the adhesive thickness over that length.

Figure 5. Failure surface of the reinforced girder, the flange (right) shows the very thick adhesive layer.

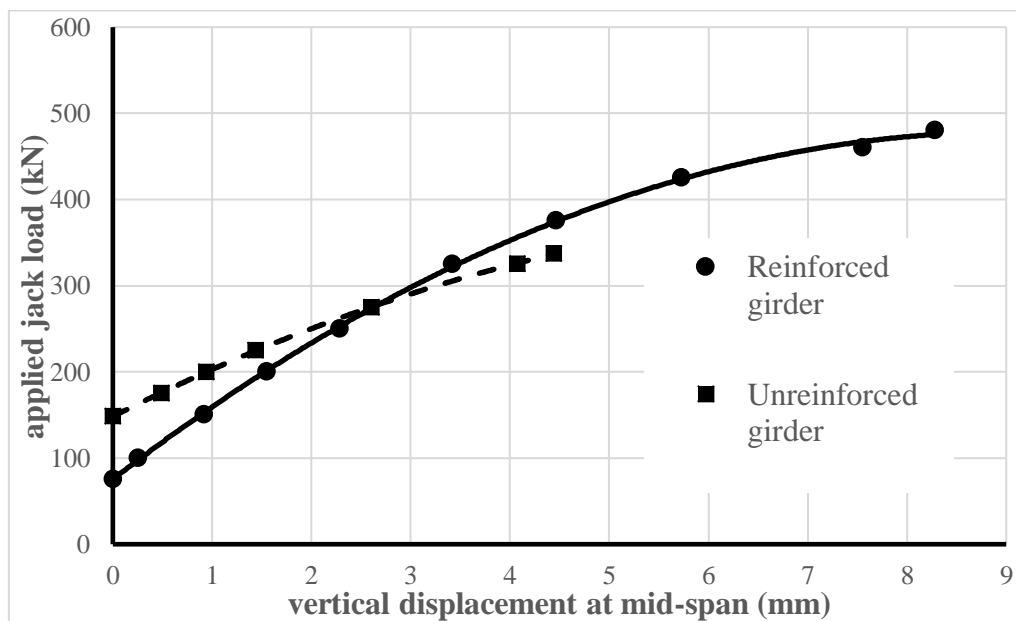
flexural displacement plots are shown in Figure 7. Using the slopes of the graphs in Figure 7 as measures of stiffness, the reinforced girder was 53.5% stiffer. The maximum flexural displacement of girder 2 was 8.3mm in the central third which extrapolates (theoretically) to 70.4mm over the full span.

Figure 7: Maximum flexural displacements in both girders

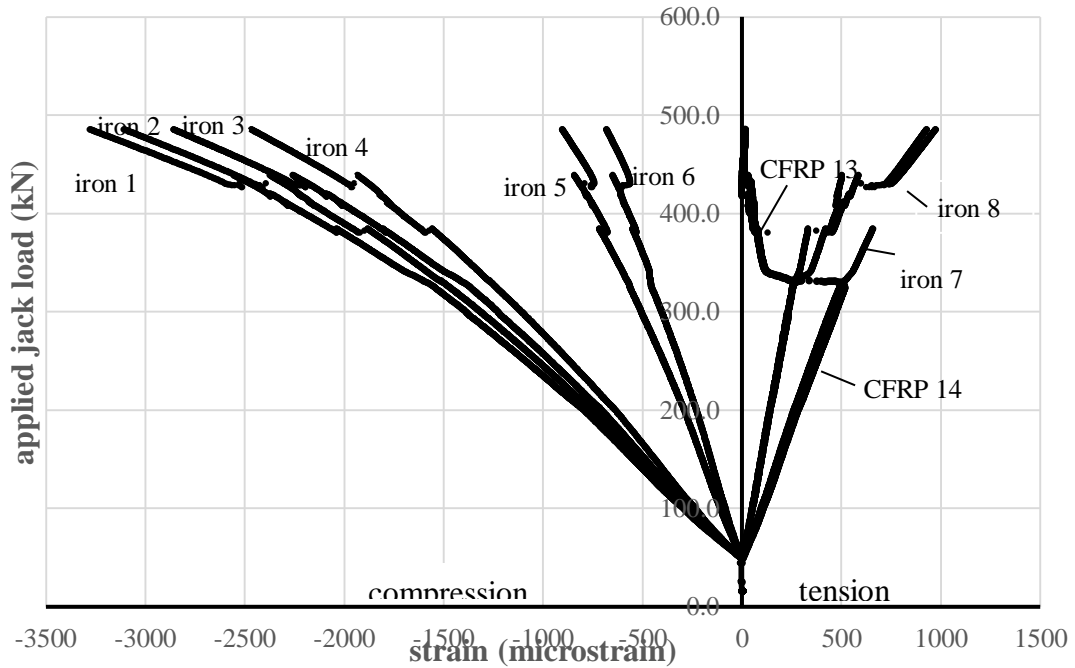
Figure 8 presents plots of the individual strain gauge readings close to midspan. As expected most of the cast iron was in compression during bending whereas the CFRP was in tension. The ‘blips’ in the curves are most likely localised debonding of parts of the carbon fibre. The major events coincided with failure of the outer plate of the CFRP. It can be seen that one plate of the pair failed at a lower load (gauges CFRP13 and CFRP14).

Figure 8: Strains near midspan, girder 2

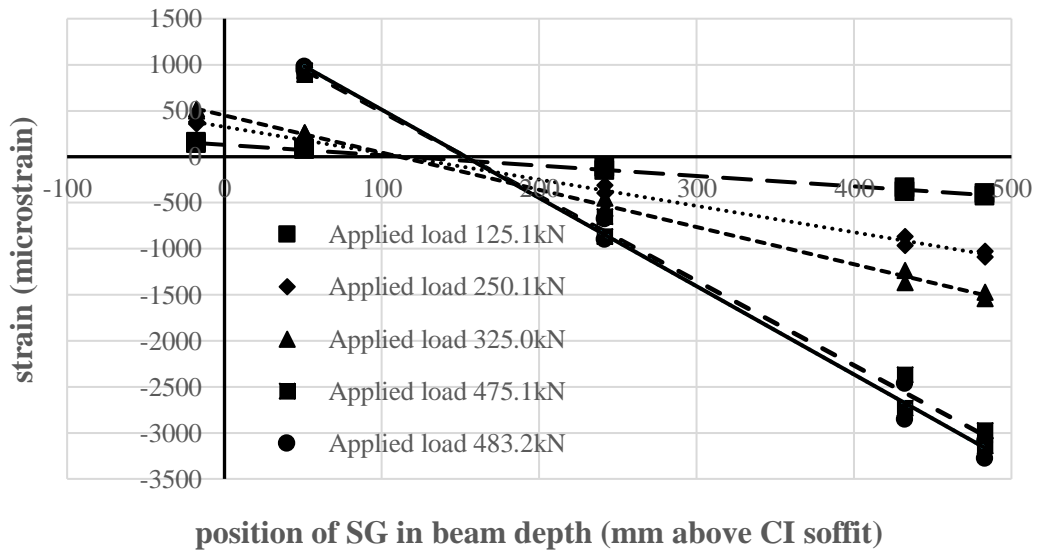
Figure 9: Strain distributions across depth of girder 2

Figure 9 shows strain distributions across the depth of the girder close to midspan. It can be seen that the distribution of strain was linear until initial failure of the carbon fibre and that the neutral axis hardly moved as load was increased. After failure of the outer plates of carbon fibre the neutral axis moved higher into the cast iron but then remained in the same position as the load increased. It is only speculation but it is possible that the strain distribution, as well as remaining linear across the depth of the cast iron, remained linear across the full depth of the remaining layers of carbon fibre. Extrapolating the strain distribution to the location of the outside fibres of the remaining carbon fibre gives a value of 1584 microstrain in the CFRP at the maximum load carried. The quoted failure strain of CFRP is between 1500 and 1900 microstrain.
