Structural Health Monitoring of Bridges in Mexico – Case Studies

ABSTRACT: Three case studies of Structural Health Monitoring (SHM) of bridges in Mexico are documented in this paper. Firstly, the SHM of the Papaloapan Bridge is presented. For this case study, the SHM was designed and installed for the structural assessment of this cable-stayed structure after two failures and loosening of its cables. Secondly, the structural assessment of El Carrizo Bridge is reported. Such a bridge has a box girder cantilevered structure section that was damaged after a fire provoked by an accident of a vehicle transporting Diesel. In this case, the SHM system was installed to control the overall rehabilitation of the bridge. Finally, a probabilistic SHM strategy for a reinforced concrete bridge is documented. The probability of failure is calculated evaluating displacements obtained via Global Positioning System (GPS) technology. Based on the results presented in this paper, the SHM of bridges in Mexico has been validated to be a useful and a cost-effective tool, not only for evaluating critical conditions and rehabilitation, but also for future structural integrity and prognosis of bridges.

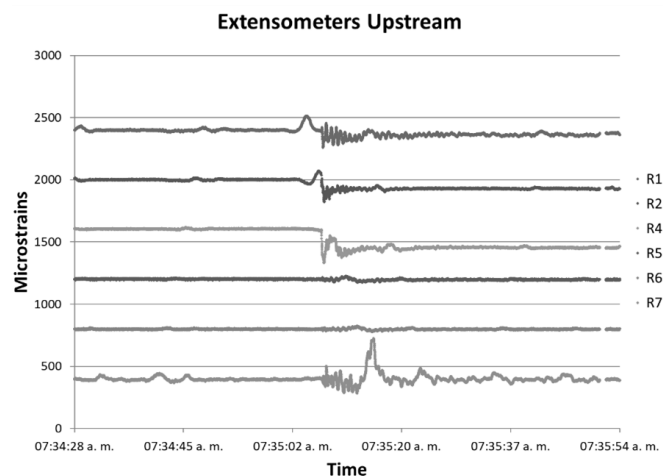
For the case of the Papaloapan Bridge, the SHM information has been important since 2013 when the system was installed. During this period, it has been possible to evaluate the integrity of the bridge, particularly when the anchoring element of cable 1, semi-harp 5 failed by fracture on June 10th, 2015 (Carrion et al., 2017). Also, the structural behavior of the structure was monitored in 2015 and 2016 during rehabilitations, respectively. In 2015, one failure was reported in the Papaloapan Bridge. Particularly, the above-mentioned event was recorded by the SHM system on June 10, 2015, at 7:35:04 a.m., as shown in the graph of the micro-strains (See Fig. 6), i.e., it can be observed in Fig. 6 that a considerable change in micro-strains is reported between 07:35:02 and 07:35:20 hrs. This may be caused by an overloading condition on the bridge.

Figure 6. Micro-strain time histories of the sensors under the upstream main girder.

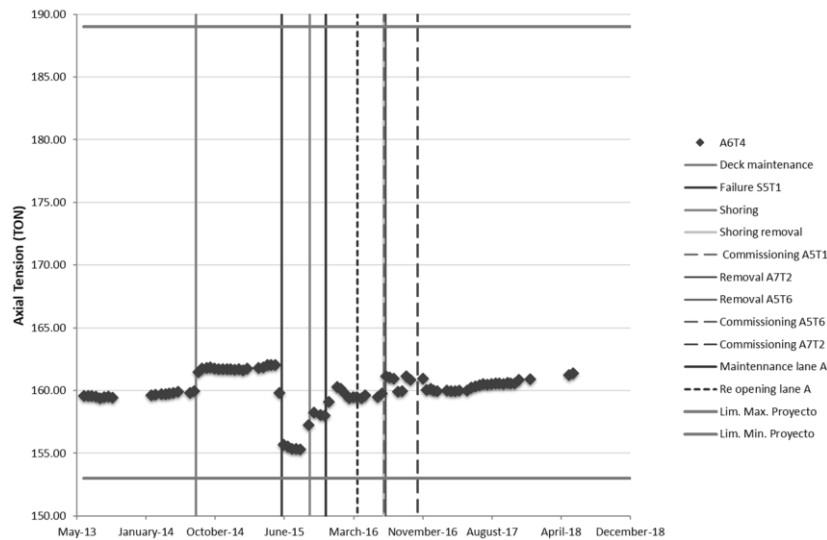
As an example of the evaluation of the structural behavior of the Papaloapan Bridge under different operating conditions in real time from 2013 to 2018 for an individual sensor, the statistical distribution of the axial tension load of the instrumented cable number 4 semi harp 6 is illustrated in Fig. 7. In these analyses, 15 days of time periods were considered, the main goal was to analyze changes in the statistical distribution type, the mean value and the standard deviation of this instrumented cable. It can be clearly observed in Fig. 7 that in June, when the failure happened, the Semi harp 6 cable 4 S6T4 lost around 8 tons of capacity. In addition, it is shown in Fig. 7 that, once the maintenance process is ended, the cable recovers the 8 tons. It is important to mention that different calibrations were performed to validate the model of the Papaloapan Bridge. However, because of the sake of brevity, such results are not presented here.

Figure 7. Tension values cable 4 semi harp 6.

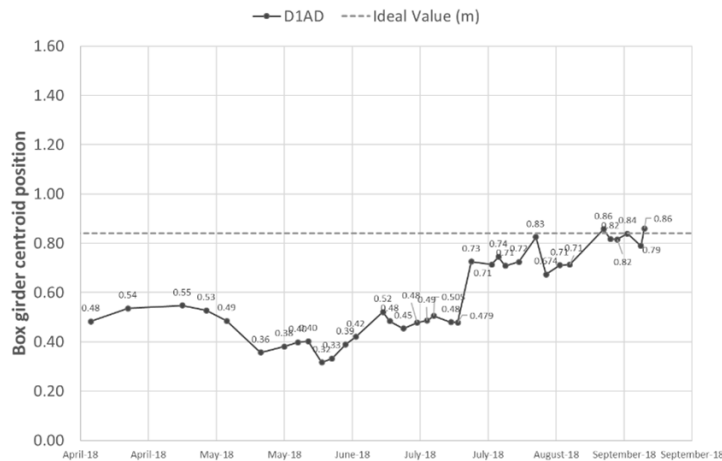
Figure 8. Box girder centroid values during rehabilitation.

It can be observed in Fig. 8 that it took around four months to stabilize the centroid of the box girder. For the case of absolute stress-strain responses, dead load changes were due to the post-tensioning of additional cables, removal of damaged bridge deck and temporary bypass lanes, or placement of new cross girders and deck sections. According to the rehabilitation stage, the alarm limits for all parameters were defined considering normal and extreme loading conditions, as well as design limits. A calibrated finite element model for all rehabilitation stages was used to understand the bridge behavior and to establish parameters limits. The calibration was accomplished through data obtained during dynamic and load testing. According to the monitoring system data and the progress status in each of the different maintenance stages, the values and variation of the first two natural frequencies were obtained through data processing of all the extensometers installed. In this sense, Fig. 9 presents the changes of the first natural frequency during rehabilitation process. It is interesting to note that Fig. 9 clearly presents the variation for the first frequency of the bridge. Also, it is observed that a significant change of this frequency was detected from June to July. Such a change was of about 0.2 Hz.

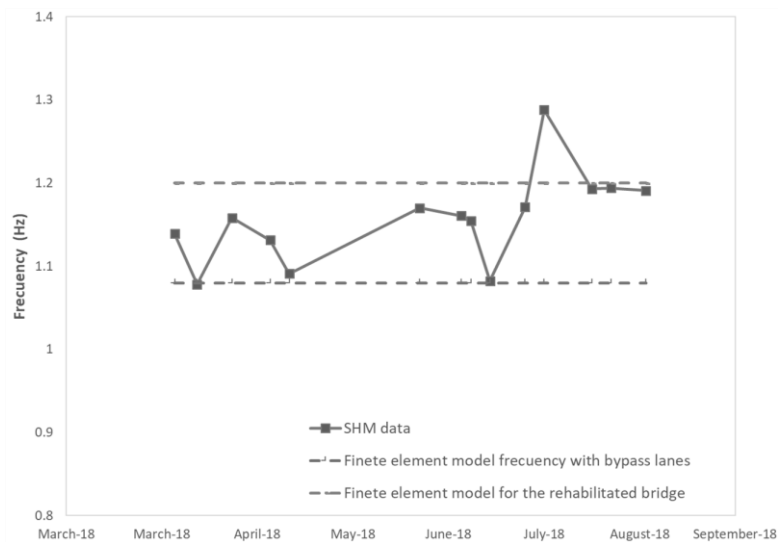
Figure 9. First natural frequency during rehabilitation.

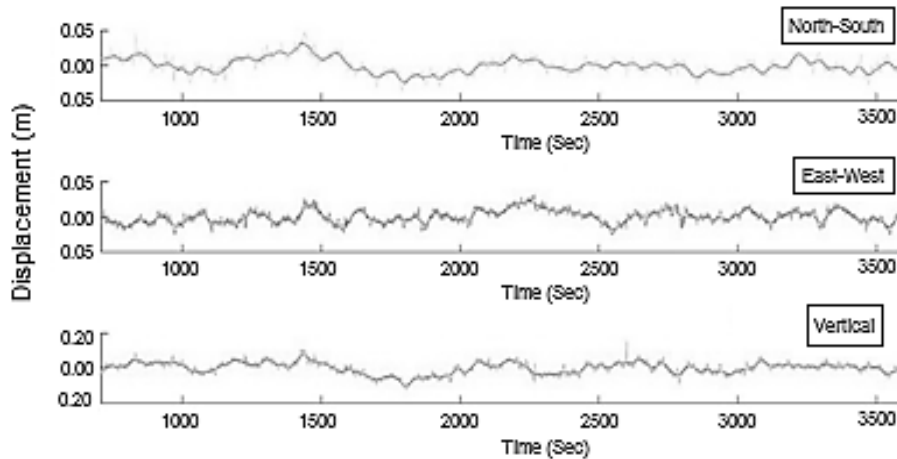
The data obtained from the GPS measurements were converted to RINEX format and later analyzed for their quality with the TEQC (Test of Quality Check) software developed by UNAVCO. Also, the data was processed with the GAMIT/GLOBK scientific software in kinematic differential mode (Herring et al., 2010). The output data of the processing with GAMIT/GLOBK were geodetic coordinates referenced to the ellipsoid WGS84. Time series were converted to apparent displacement with respect to the mean value. In addition, several filters were applied to the time series to eliminate noise and errors, such as multipath. The moving average filter was used to extract the semi-static displacements from the time series, and to obtain dynamic displacements, the Chebyshev filter type 1 was applied. In this way, time series were generated in terms of semi-static and dynamic displacements obtained via GPS, respectively. Fig. 10 presents the apparent and semi-static displacements in the three components for a specific point on the bridge that presented the greatest deflection (Vazquez-Becerra et al., 2017). The results illustrated in Fig. 10 correspond to the measurements performed from 08:00-09:00 hrs. in the main deck of the bridge. On the other hand, to study the stochastic behavior of semi-static displacements, histograms were built for each of the measurement sessions. Fig. 11 presents the histogram corresponding to the semi-static displacements presented in Fig. 10. Once the PDFs

Figure 10. Apparent and semi-static displacement for the Juarez Bridge.

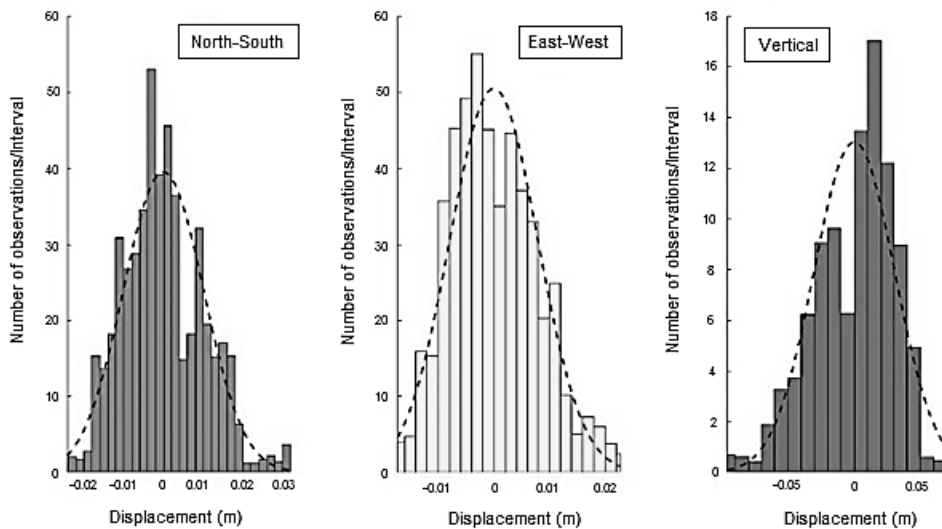
have been generated for every session and taking the deflection limits recommended by AASHTO (2010) for a span length (L) equal to 20 m, the probability of failure (p_f) is calculated (see Table 1), in average, for all measurement sessions corresponding to the Monday session. Based on the results presented in Table 1, it can be stated that the session with the highest probability of failure was the second session (12:00-13:00 hrs.), with a value greater than 80%. This may be justified since at this time of the day is the highest traffic. It is important to mention as well that the PDFs presented in Fig. 11 correspond to a Normal distribution, i.e., the semi-static displacements are presenting a Normal type distribution.

Figure 11. Histograms for the Juarez Bridge.
