Damage Assessment of Concrete Sulfur Storage Structure in Petrochemical Industry

Muhammad RAHMAN¹, Hassan AL-KHALIFAH², Sami AL-GHAMDI²,
Mohammed IBRAHIM¹, Fuad AL-YOUSEF¹, Ali AL-GADHIB¹

² Consulting Services Department, Saudi Aramco, Dhahran, Saudi Arabia

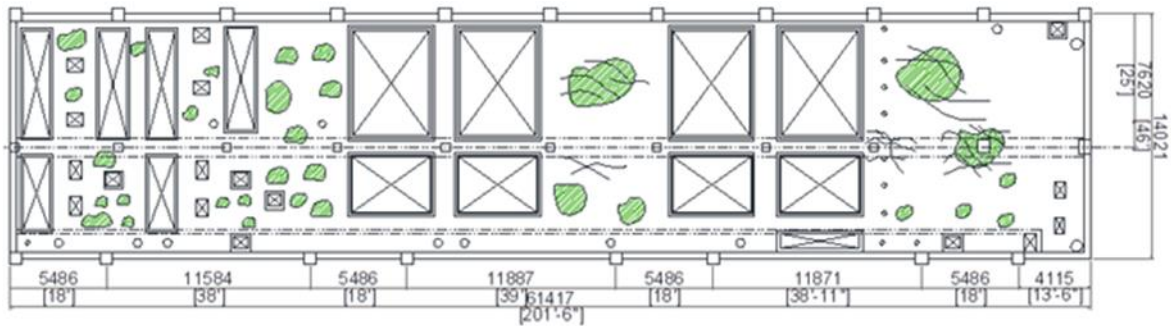
Visual inspection of the roof slab was carried out in the first phase together with hammer sounding to map the distresses including delamination and spalling. The visual survey also included photographic evidence of the distresses found in the structural components of the sulfur pit inside the pit in the second phase. The delamination survey on the top of the roof slab by hammer sounding indicated distress in several patches at the top of the roof slab as shown in Figure 2. A layer of new repair concrete with pea gravels, 25 mm thick, was identified on top of the roof slab of the sulfur pit at some locations. Shrinkage cracks were seen on the top slab.

Figure 2. Cracking and delamination on the top side of the roof.

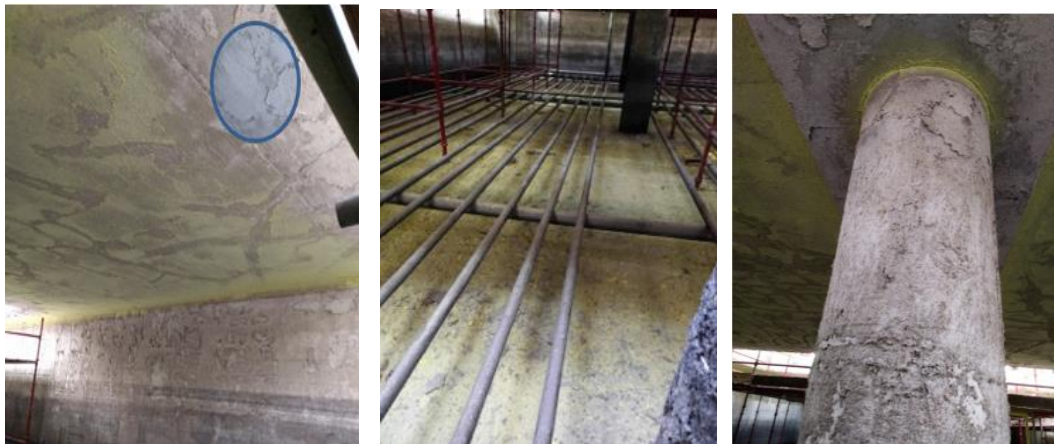
Inside the pit a layer of thin coating exists on the ceiling of the roof slab, walls and the columns in the sulfur pit. The coatings are burnt, charred and have peeled off at several locations. Coatings on the columns have charred and turned black (Figure 3). No delamination or spalling of concrete

observed in the ceiling of the sulfur pit. The coating may have inhibited the corrosion of steel in the top slab. A thick layer of sulfur is found attached to the coating at the junctions and near openings as seen in Figure 3. The walls of the sulfur pit show vertical cracks emanating from the bottom and going up to the top that can be attributed to thermal stresses. The concrete is very weak and friable and the concrete top layer could be removed easily in some portion indicating acid attack.

Figure 3. Delaminated coatings on the column and sulfur adhering to the surface at roof soffit.

4. A layer of thin layer of coating, which is burnt, charred and have peeled off at several locations exists on the ceiling of the roof slab, walls and the columns in the sulfur pit. No delamination or spalling of concrete observed in the ceiling of the sulfur pit. The coating may have inhibited the corrosion of steel in the top slab.

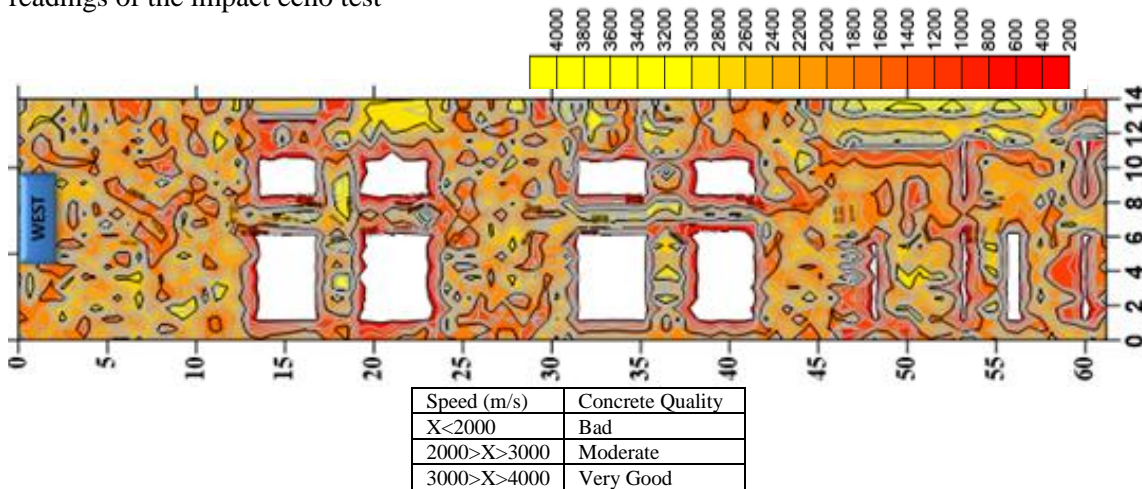
The results of impact echo tests at the top slab with the SRU in an operational state is shown in Figure 4. Irregularities in the concrete were identified based on the shear wave intensity. The ultrasonic pulse echo survey indicates that a significant portion of the roof slab has a weak

concrete. Delamination of the top thin coating layer on the concrete could have masked the readings of the impact echo test

Figure 4. Impact echo readings at the roof slab of sulfur pits.

2. The ultrasonic pulse echo survey indicates that a significant portion of the roof slab has a weak concrete. Delamination of the top thin coating layer on the concrete probably masked the readings of the impact echo test. In most of the areas on the roof slab, half-cell corrosion potentials (HCP) recorded were less negative than the threshold value of -350 mV, indicating that the reinforcing steel in these areas is still in passive state of corrosion.

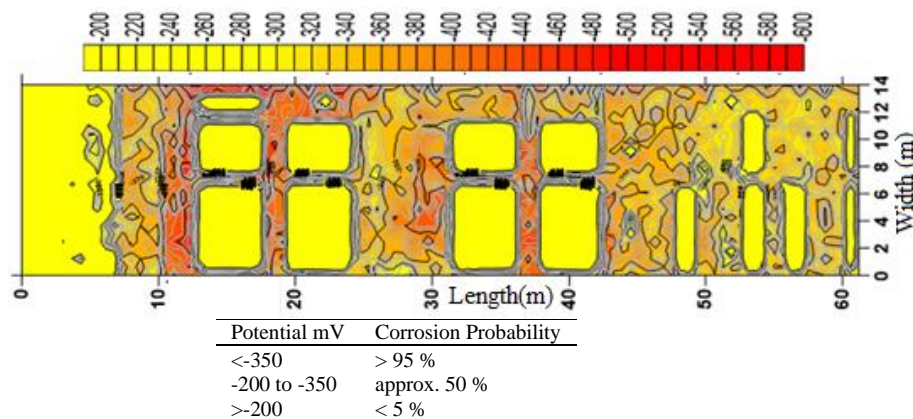
Corrosion potential for detecting reinforcement corrosion and state of passivity of the reinforcing steel in concrete structures was based on ASTM C876 (2015). Potentials were measured at a grid spacing of 600 x 600 mm, in longitudinal and transverse directions on the top of the roof slab. This NDT test was carried out after shut down as in an operational state no breakout for reinforcement exposure was allowed. A reference electrode was placed on the concrete surface, which is connected via a high impedance Voltmeter ($> 10^9$ Ohms) to the reinforcement cage. Corrosion potential mapping for the roof slab is shown in Figure 5. It can be seen that the corrosion potential at most of the roof slab is within threshold limit. Limited corrosion was identified around openings.

Figure 5. Corrosion potential mapping.

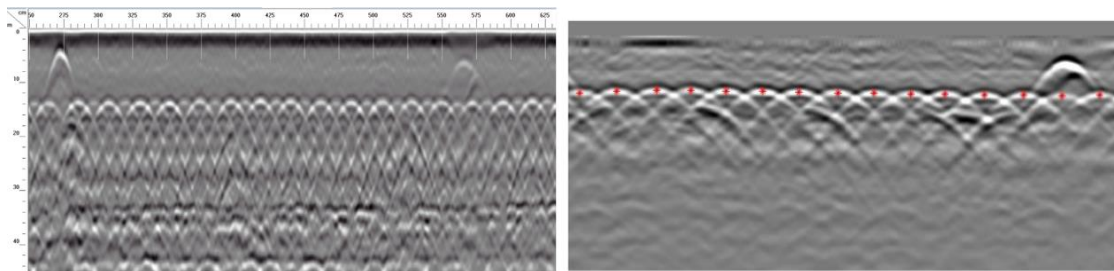
A 2 mm thick fiber-reinforced cementitious layer exists on the top of the slab. The cover to reinforcement is about 120 mm as can be seen in Figure 6. The thickness of concrete cover for the top rebar layer is approximately 130 mm from the top. The depth of bottom rebar layer is about 320 mm. The total depth of the roof slab is about 420 mm as obtained from the GPR data. The top reinforcement location is clear but the bottom reinforcement location can only be judged. It can be seen that reflection from good reinforcing top steel is very sharp and some weak reflections is clear from the good bottom steel. On the other hand, the corroding reinforcing steel completely blankets the area at the bottom of the element using GPR. It can be seen that the bottom reinforcement cannot be identified at locations where the top bars are located.

Figure 6: GPR indicates a thin layer of fiber-reinforced cementitious layer on the top of slab with a cover of about 125 mm.

3. The GPR results shows that only about 5% of the top slab reinforcement shows signs of severe corrosion. Moderate corrosion is significant particularly around openings. Concrete cover is found to be very high (about 125 mm) at the top. The thickness of slab is 420 mm (drawings shows 375 mm). The GPR study on LIVE sulfur pit does not reveal the condition of the reinforcement at ceiling inside the pit. GPR gives robust indication of corrosion of reinforcement at the top of the slab. If the reinforcement at top is corroded, the bottom reinforcement is completely masked.

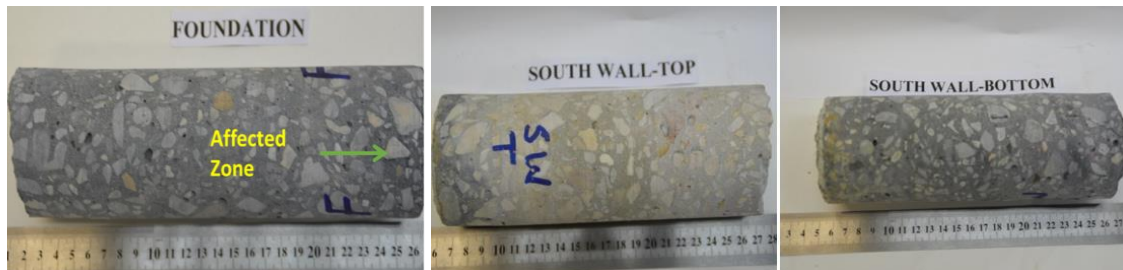
Figure 7 shows the concrete cores obtained from inside the pit (ASTM C42, 2018) . In the core from the base slab (left) about 2.5 to 3 cm of the core appears to be affected with sulfur penetrating into the concrete. The cores obtained south wall from bottom (middle) and top (right) shows the acid attack on the concrete surface. The penetration of acid attack up to 4 cm can be seen in south wall core obtained from zone affected by acid vapors. Dark color concrete core can be seen in the zone which remains immersed in sulfur. In the south wall top core, the surface layer is weak and friable. The cores obtained from the North wall from bottom and top shows that the concrete in top layer in the North wall has lost its strength and was easily broken. The bottom part of the North wall has been repaired with a 250 mm thick repair concrete as is evident from the core. The

acidic vapor appears to have penetrated to a depth of 800 mm in the vapor zone on the top of the North wall.

Figure 7. Concrete core retrieved from north wall top (left) and bottom (right).

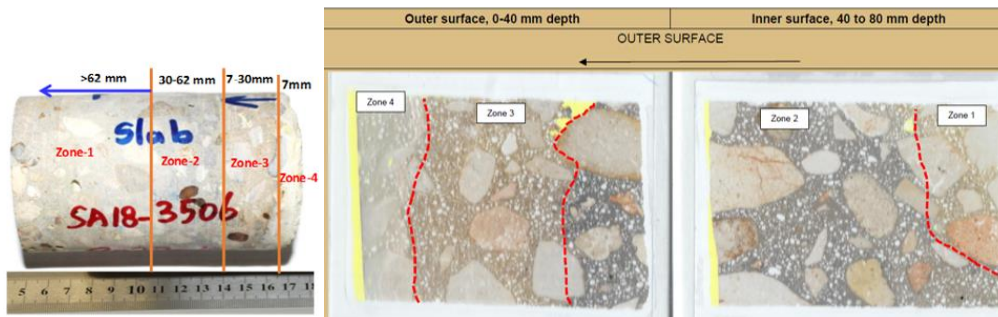
Figure 8. View of thin section showing zones of alteration within the concrete

It can be seen from the figure that the concrete in Zone 1 at the interior of the core is sound. In the outer most layer (Zone 4) there is an abundant evidence of sulfate attack in terms of abundant cracks sub-parallel to the outer surface infilled by sulfate minerals, air voids infilled by sulfate minerals, partial replacement of the cement matrix by sulfate minerals and layered deposits of sulfate minerals within and adjacent to coarse aggregate particles.

In the second zone from the surface of the ceiling (7 – 30 mm) there is a moderate evidence of sulfate attack, sporadic air voids microcracks infilled with sulfate minerals. Alteration of the cement matrix and increased densification is also observed. The third zone from the surface extending from 30 mm to 62 mm shows minimal evidence of sulfate attack, sporadic air voids microcracks infilled with sulfate minerals. Alteration of the cement matrix and increased densification can be observed.

11. The petrography of concrete core from the slab shows that the acidic sulfur vapors have affected the soffit of slab. Top 10 mm seems to be heavily affected. Petrography shows weak, friable and cracked concrete in top 7 mm. There is a moderate level of sulfur penetration in the slab, up to a depth of 30 mm with voids and microcracks filled with sulfur. The maximum depth to which the sulfur has infiltrated into the slab is up to 60 mm.
