# Methodology of efficient assessment of structural deformation from Nonintrusive techniques for Civil Heritage conservation.

Second Conference on Smart Monitoring, Assessment and Rehabilitation of Civil Structures

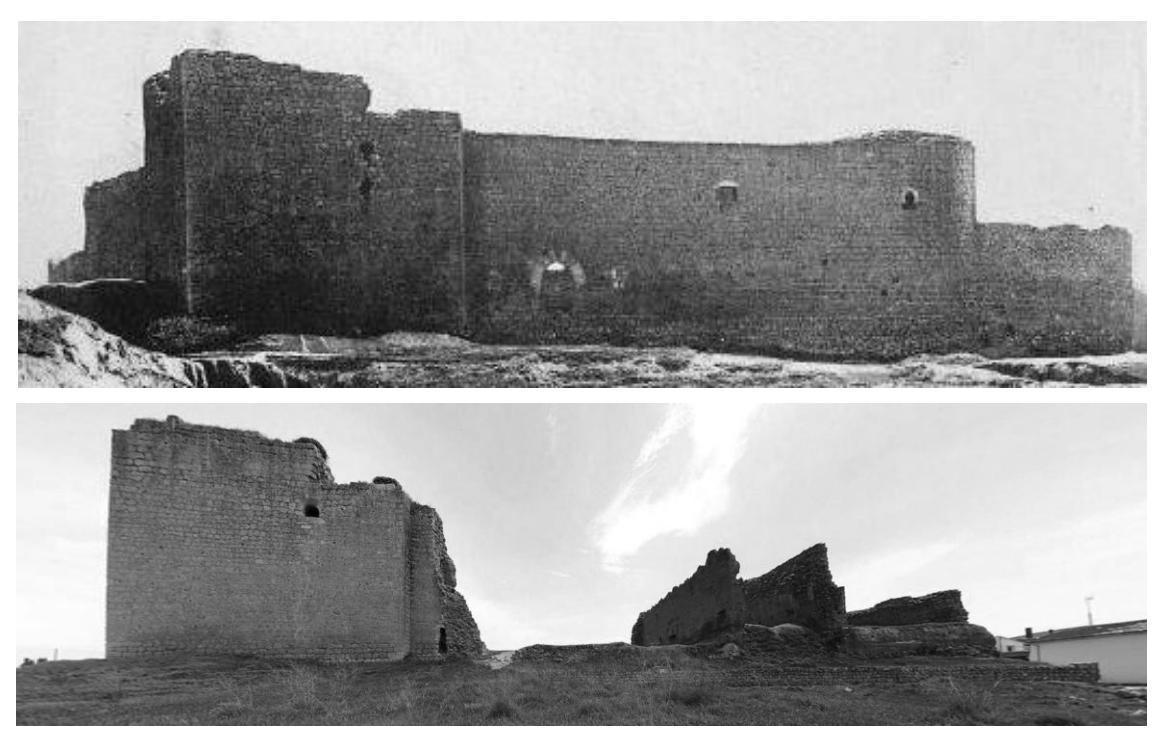
Different conquests, adjudications and transformations that have had throughout history, highlighting the invasion by Napoleon's troops in 1810, have accelerated the property spoliation (Figures 1 and 2 show the further deterioration in last 150 years). Although in 1969 was performed a partial restoration, the lack of continuity in the maintenance work has led to the current ruin state.

Figure 1 [upper]: Daguerreotype Stock, Northwest Castle facade, late nineteenth century, Figure 2 [bottom]: Picture taken in the same facade, March 2012.

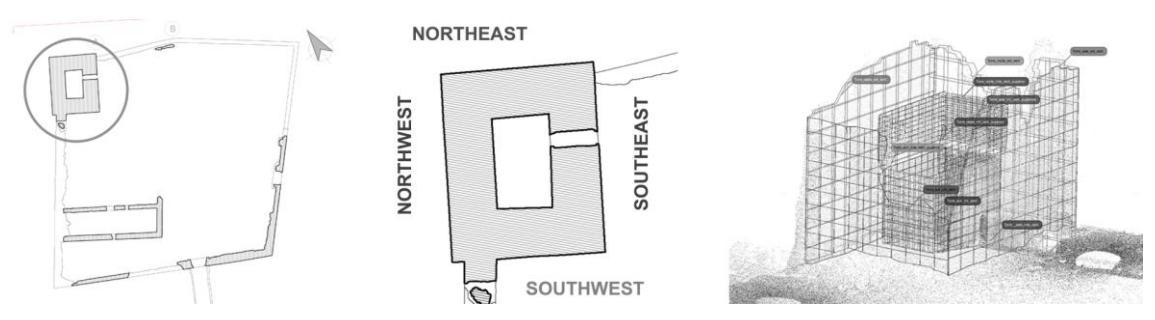
Figure 3. [left] Top view of Villagarcía de Campos Palace [center] Detailed top view of the Donjon and assessed walls [right] Plans adjusted to the internal and external Donjon faces.

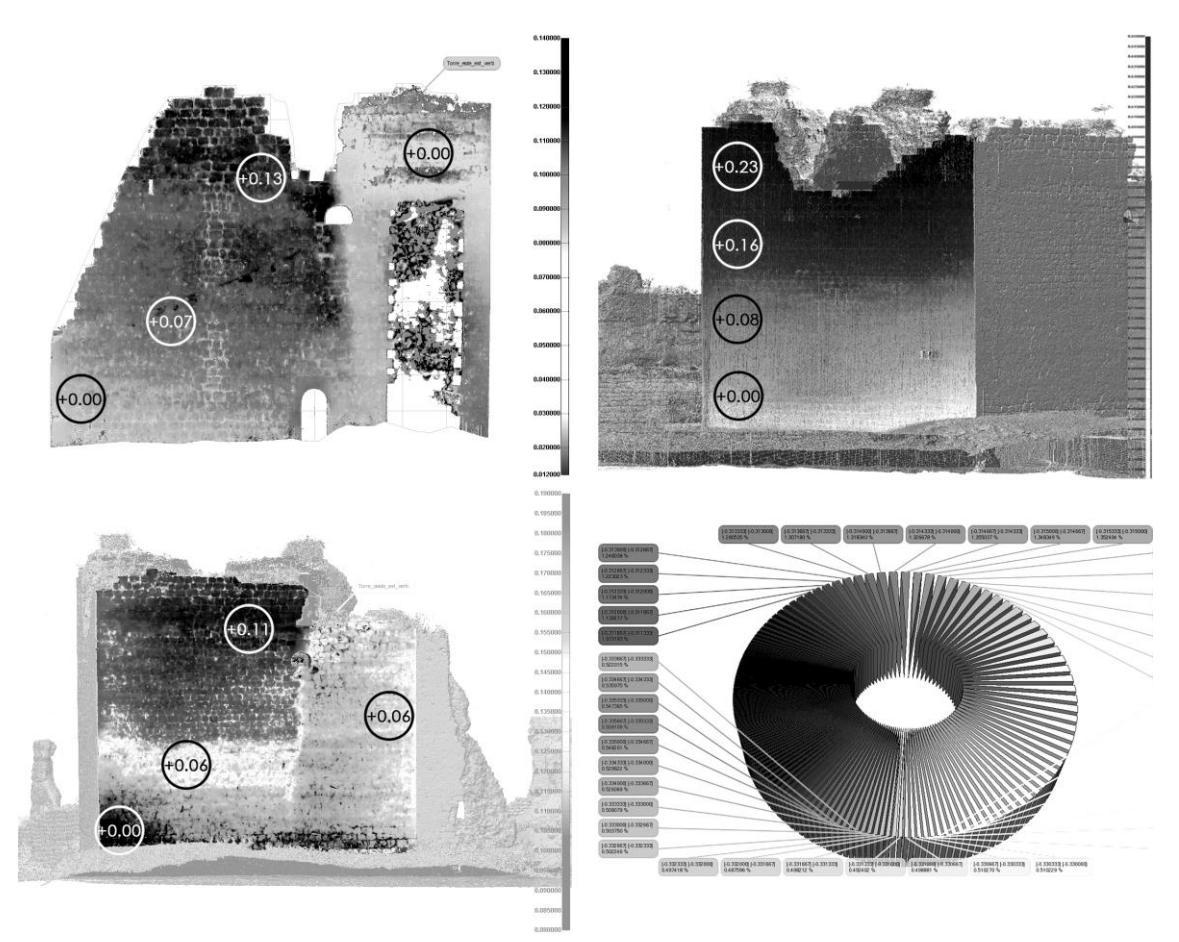
Respect to vertical plane [B]: The comparison was performed over 6,784,000 points, with a Standard Deviation (StdDev) of 0.000621 and a Root Mean Square (RMS) of 0.0004. In this facade, shown in Figure 5, is detailed how the upper left area is offset from the bottom in order of 7 cm, explaining the presence of a tie rod, settled in the 1969 restoration, which seeks to bind the upper left section. On the right we can see the top retracted 3 cm over the bottom, in the same vertical. The cause can be attributed to structural depletion due to efforts concentration by the presence of the supporting Rampart, pushing this part of the Tower. The analysis in the inner wall has confirmed the similar behavior found in the outer, concluding that the two facing rows are well coupled.

Respect to oblique plane [A]: The comparison was performed over 3.897.000 points, with a Standard Deviation (StdDev) of 0.011397 and a Root Mean Square (RMS) of 0.0114. The assessment with the oblique plane (locally) allows to discover the presence of an inclined line quite marked in the central part of the wall, suggesting an old fissure coated with reinforcing, which has left a little outside trace on the same plane.

Respect to vertical plane [B]: The comparison was performed over 4.784.000 points, with a Standard Deviation (StdDev) of 0.010457 and a Root Mean Square (RMS) of 0.0104. Has been obtained in the map, a gradual curved outward in the vertical direction of about 19 cm, shown in Figure 6.

Cause can be attributed to movements or resentment in foundation, by deficiency in its performance. From history we know that, based on the wealth of the proprietors, the foundation was correctly performed or simply was placed larger stones for loads transmission. Its failure implies a characteristic differential settlement of this movement respect the vertical axis.

Analyzing the inner wall can be noted the facing seems to follow the movement of the outer wall, but with a different net head, the outer face in its upper part has an inclination of approximately 19 cm, the inner barely reaches 2 cm. This means that internally, the wall does not have the same movement, due to degradation of interior fillings. Often because of an invasion of the inner content by rainwater, occurring internal material degradation by saturation, wettings or deposition of soluble salts, inner crystallization can exploit the compact structure.

Respect to oblique plane [A]: The comparison was performed over 1.783.960 points, with a Standard Deviation (StdDev) of 0.010456 and a Root Mean Square (RMS) of 0.010462. From the comparison analysis, we can observed a singular behavior zone. At the bottom there is a roughly circular shaped protrusion, probably caused by an old collapse, filled with several tons of cement and covered outside with stones, does not pose danger for the entire structure at this time.

Figure 5 [upper left] Comparison between Vertical Plane and Southeast Facade / Fig. 6 [upper right] Comparison between Vertical Plane and Northeast Facade / Fig. 7 [Bottom left] Comparison between Vertical Plane and Northwest Facade / Fig. 8 [bottom right] Report generated from Polywork IMInspect for a detailed assessment of normal variations.

Respect to vertical plane [B]: The comparison was performed over 4.844.000 points, with a Standard Deviation (StdDev) of 0.00982 and a Root Mean Square (RMS) of 0.009839. Is easily visualized (Figure 7) how the left side behaves differently respect the right. We observe a vertical line dividing the two regions sharply, and is located up to the window and the internal tie rod. At horizontal level of the same left side is a vertical unevenness of 7 cm. We can guess this wall also have foundation troubles, although the tether with the tie rod in the upper region seems to compensate the movement, giving it more stability respect Northeast Facade. Inner wall behavior continues the path of the outer, so not suspected of any displacement between Masonries, indicator of the good filling performance.

Respect to oblique plane [A]: The comparison was performed over 1.787.960 points, with a Standard Deviation (StdDev) of 0.00984 and a Root Mean Square (RMS) of 0.009838. Can be noticed some irregularities in the middle and at the vertex with the rest of West facade due to degradation of the stone. Its basic cause is founded in the surface exposure to the area of greatest winds influence, intensifying erosion by exposure to water and temperatura and identifying problems of material detachments.
