Life-time extension of masonry-arch bridges

Philipp Rück¹, Bruno Portmann¹

¹ mattec+, Schinznach Dorf, Switzerland

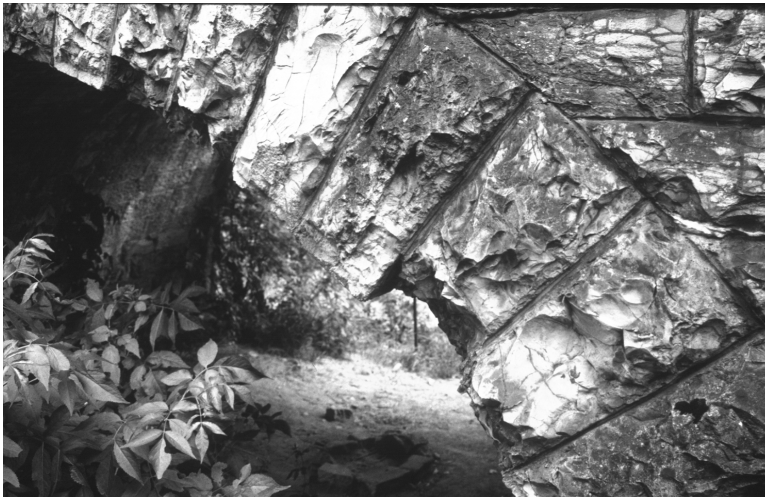
Figure 2: Crumbling decay on Jurassic limestone

Structural decay symptoms relevant to the load-bearing capacity of natural stone masonry railway bridges are primarily the result of strong wetting in conjunction with freezing. The reason is usually a lack of, or defective sealing. More comprehensive studies performed by the Swiss Federal Railways (SBB) have confirmed that it is not the age of railway bridges that is indicative of their condition but the question whether and how well a structure has been protected from wetting during its lifetime. Secondly, the severity of damage depends on the existing type of building materials and the construction method used. Sandstones and Jurassic limestones widely show deep-seated damage, while Alpine limestones, granites and gneisses – due to their high weathering resistance – hardly show any damage.

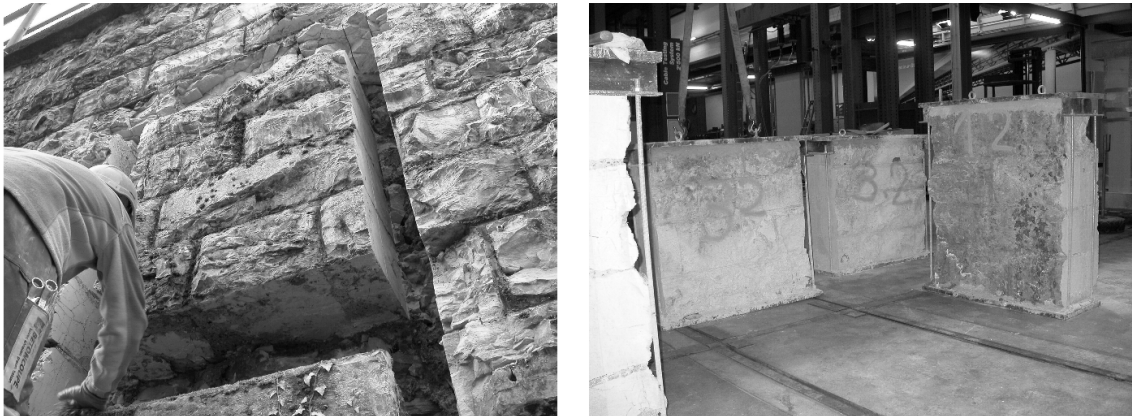
Figure 3: Removal of masonry object for a compression test

Central for assessing structural soundness is determining the strength of the masonry. For this purpose, Swiss standard SIA 266/2 (2010) provides a procedure for estimating, based on the type of masonry bond, the compressive strength of the rock, and additional parameters. Recent series of tests on masonry objects have shown that this procedure, at least when the masonry is intact, does not result in excessive compressive strength values for masonry. In quite a few cases, however, the impact on the strength of the masonry caused by damage from weathering and use is hard to assess. In cases of far-reaching crumbling decay in limestone masonry, for example, the resulting estimated reductions varied widely as compared to the as-new condition (Figure 2). In such cases, the last resort is to physically test masonry objects taken from the structure (Figure 3). In this actual case the result was that the compressive strength of the masonry had to be derated by about 60% in case of crumbling decay, as compared to equivalent masonry free of decay symptoms. Such tests are expensive, cannot be applied systematically and consequently, are only of an exemplary nature.
