Monitoring the static and dynamic behavior of The New Svinesund Bridge

R. Karoumi¹ and P. Harryson²

¹ The Royal Institute of Technology (KTH), Stockholm, Sweden

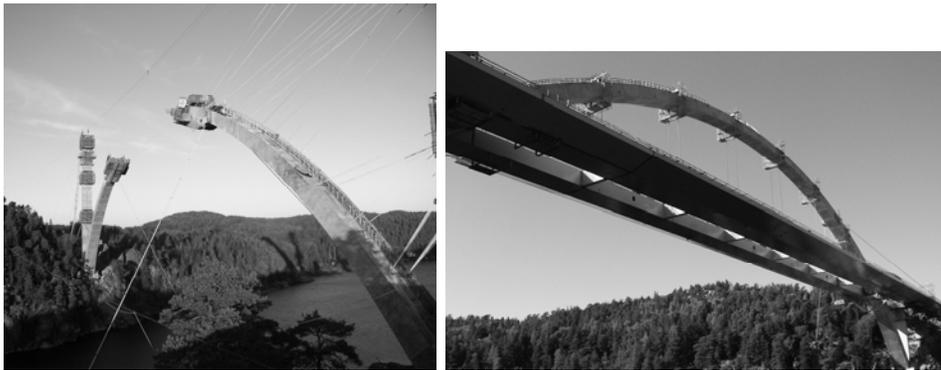
Figure 2. The New Svinesund Bridge joining Sweden and Norway. The main span is a single arch with a bridge deck on either side of the arch. Photographs of the bridge under construction.

The construction of the arch used a climbing formwork and was done in parallel on the Norwegian and Swedish sides. During the construction phase, the arch was supported by cables which were anchored to temporary towers, see Figure 2 (left picture).

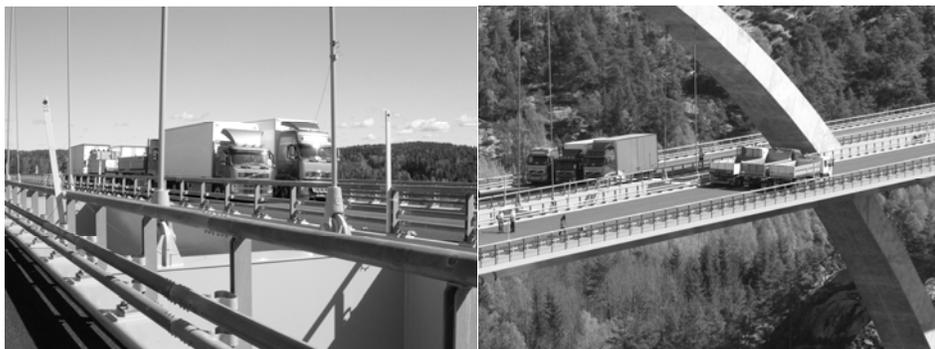
Figure 4. Loading pattern C with 8 lorries (left photo) and loading pattern E with 6 lorries (right photo).

In the static tests, eight 25-ton lorries (see Figure 4) with known dimensions and axle weights were positioned according to 7 different loading patterns. Table 1 gives the order in which these
