Clean masonry strengthening for inside application

ABSTRACT: There are different solutions available which can strengthen masonry as a very vulnerable construction material in seismic regions. The efficiency of the most systems is verified by many scientists, but only rare the practical issues are solved. In this paper a clean strengthening system with many benefits is presented. The concept provides an application of thin wallpaper like glass fibre textile glued directly on an existing plaster in a building with special high ductile water based polyurethane adhesive. The practical benefits are: No plaster has to be removed, very fast and clean application like wallpaper hanging, health friendly material, and high deformable connection plaster to textile. In the paper different experimental work on static cyclic loaded masonry walls in in-plane direction and dynamic wall tests in out-of-plane direction are presented. The results have confirmed the effectiveness of the proposed retrofit scheme.

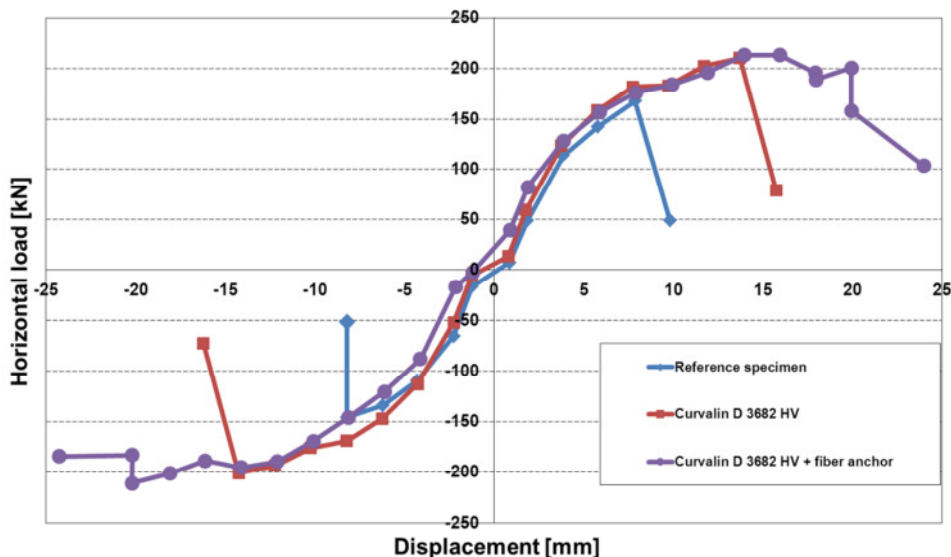
Figure 2. Envelopes of the hysteresis curves of three masonry walls

cyclic displaced head beam the displacement and the horizontal force were measured. Representative results of the envelopes of the hysteresis curves from the unreinforced masonry (URM) and the two reinforced masonry (RM) tests (1.25 m x 1.25 m) are shown below in figure 2. The maximum resistance force of the URM wall was 177.28 kN, for the RM wall 212.16 kN and for the wall with additional anchors 214.16 kN. The increase of horizontal shear force capacity in comparison to the URM wall was 20 %, but much more important was the increase in ductility of factor 2. The anchors were especially for the after cracking behaviour very useful and lead to a maximum deformation of 24 mm before anchor pull out resulted torsion in the wall.

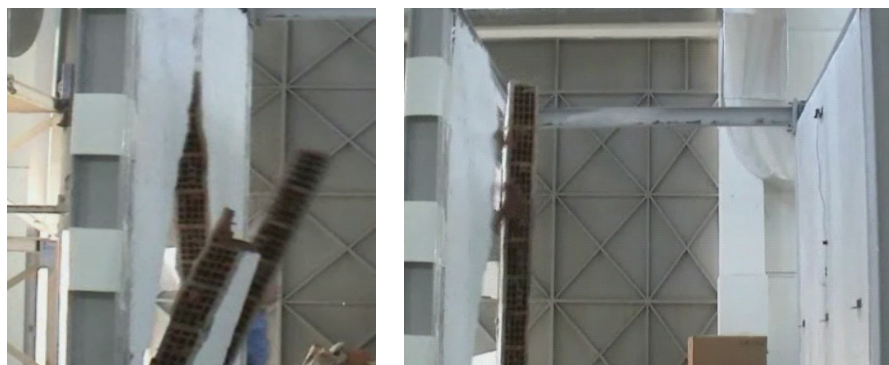
Figure 7. Collapse of the middle wall part (left), total collapse of the unreinforced wall and failure free reinforced wall (right)

For further damaging the walls sine sweep with the natural frequency was chosen as load conditioning. The failure of the unreinforced wall developed in several stages. After the load under the 300% Gölcük time history a fine hairline crack was starting from the central wall and the upper side in the vertical direction to extend downwardly. After first sinusoidal oscillation in the range from 1 to 25 Hz, a plan view image of an inverted Y-crack developed (analogous to the break line theory) with strong stone failures. Further crack mechanism was a collapse of a triangle section like shown in figure 8. In the end the two remaining trapezoids collapse. In contrast, the wall with MapeWrap EQ System could not be damaged under maximum sinusoidal load of 3 g

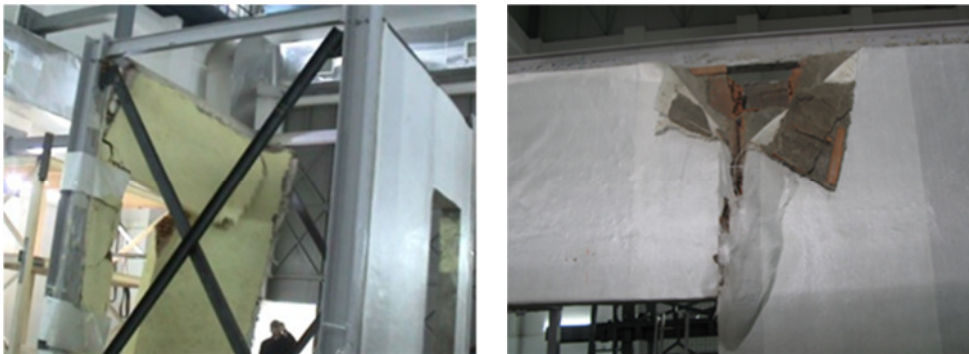
Figure 11. Collapse of the unreinforced wall (left), tension failure in the fabric (right)

The further loading resulted in a total collapse of the unreinforced wall at a PGA of 1.28 g. Synchronous first fibre cracks were locally at the corner position determined. The fourth and final sine excitation led a PGA of 1.97 g to a failure of the fabric, so that similar to the unreinforced wall developed a similar fracture pattern of the masonry. The comparison of the maximum PGA's under similar level of claims therefore had a reinforcing effect of $1.97 \text{ g} / 0.76 \text{ g} = 2.6$.
