Monitoring and control of the longest suspension bridge in Brazil during its complex rehabilitation process

ABSTRACT: The iconic and centenary Hercílio Luz Bridge in Florianópolis was the first road link to be erected between the island of Santa Catarina and the mainland. It has been closed to traffic for safety reasons for more than 20 years, after a crack was found on one bar of the suspension system. A major restoration project is ongoing, with a planned opening to traffic by the end of 2019. This demanding work includes the restoration and reinforcement of the foundations, metallic superstructure, bearing supports, eye-bars, and suspension cables as well as the reconstruction of the road deck and construction of new foot and cycle decks.

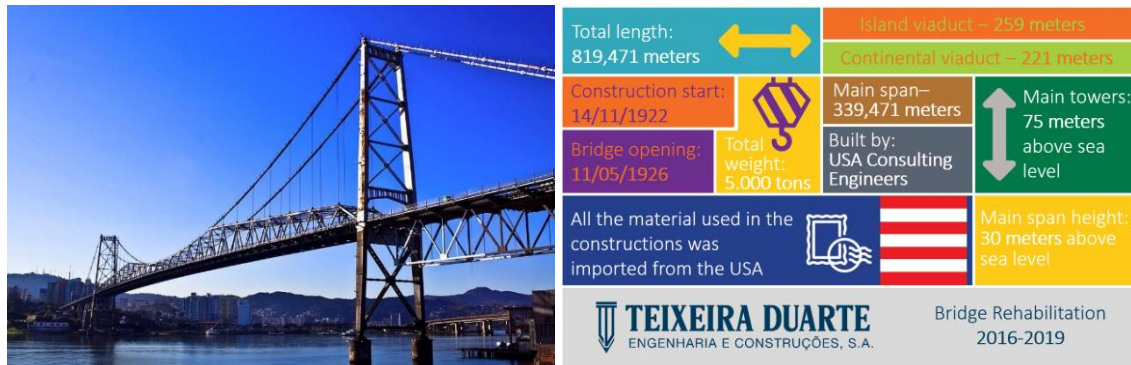
Figure 1. Hercílio Luz Bridge with some facts and figures.

Designed in 1922 and put into service four years later in 1926, Hercílio Luz Bridge (Figure 1), became the first road bridge connecting the island of Florianópolis, part of Santa Catarina state, Brazil, to the mainland, Steinman (1928). Being in a maritime location, the bridge has been subjected to intense corrosive aggressions and the natural wear of decades. It has also faced changes to the load and number of vehicles that overcame the design standards of its time. Other bridges have inevitably suffered damage or even collapse due to complex factors such as the environmental load variation, natural disaster and material degradation, Ko et al (2005).

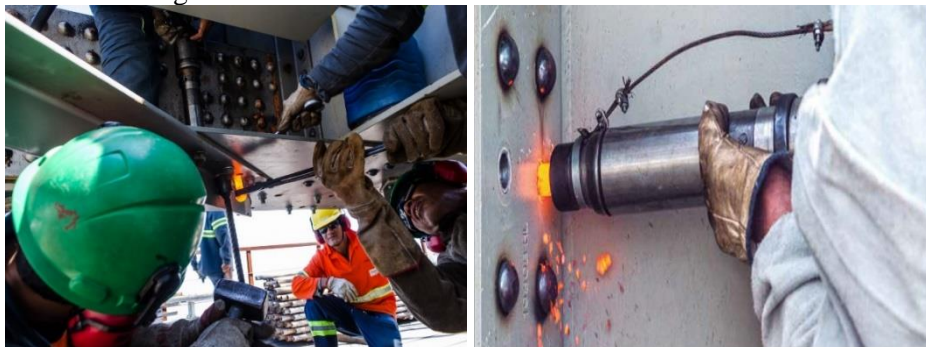
Figure 2. Attachment of rivets.

The iconic and historic importance of the bridge to the people of Santa Catarina increases the demands of a project where the structure's geometry and construction method details need to be kept unchanged. This constant care can be gauged, among others, by the more than 200 000 rivets attached during the rehabilitation works so far.

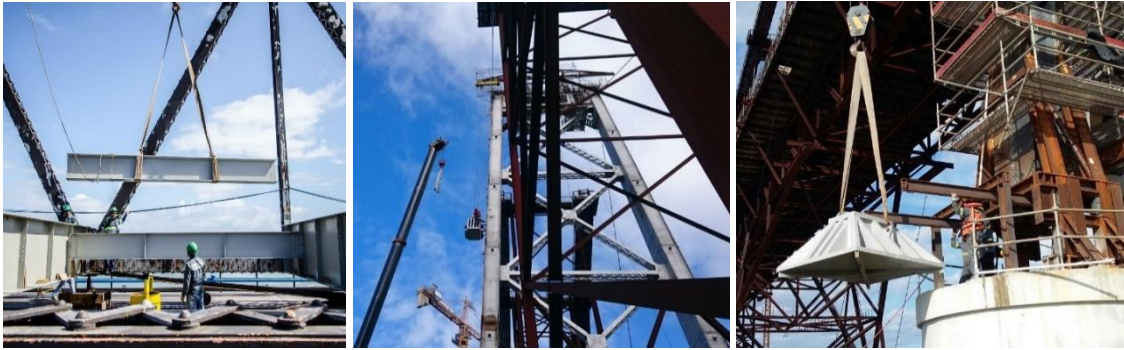
Figure 3. Replacement of the midspan deck (left), of a saddle on the top of the main tower (middle), and of a main tower supporting bearings (right).

For the suspension system replacement, main cables built from 360 eye-bars are linked by pins and 28 supporting hanger cables. A load transfer of the total midspan was required from the suspension elements to the temporary support structure erected below the central span. Such a critical task, especially when performed on an old and damaged structure, required careful control and monitoring. For this project, Teixeira Duarte decided to opt for HBM technology, including sensors and data acquisition systems of different technologies.

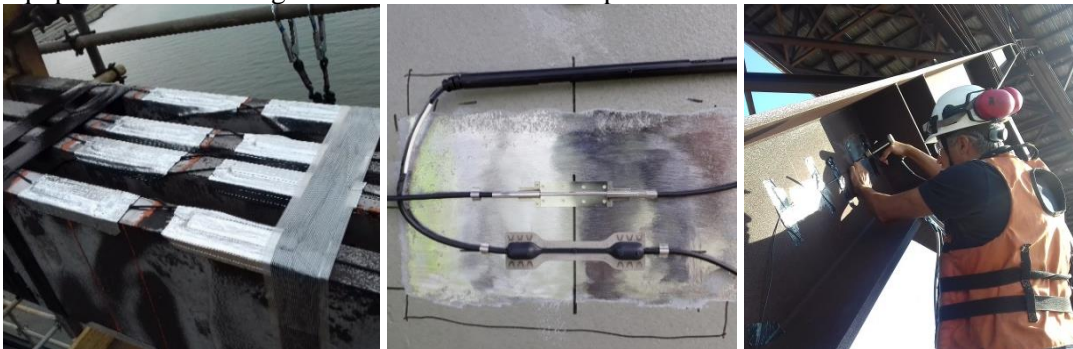
Figure 5. FS62 Composite Strain Sensor and FS63 Composite Temperature Sensor (left), FS62 Weldable Strain Sensor and FS63 Weldable Temperature Sensor (middle) and spot-welding process (right).

Two installation methods for the sensors were selected depending on the element of installation. Bonded sensors, with faster installation times but long-term dependence on adhesives, were chosen for installation on elements to be replaced. Spot weldable sensors that require special equipment for installing were chosen for new or kept elements.

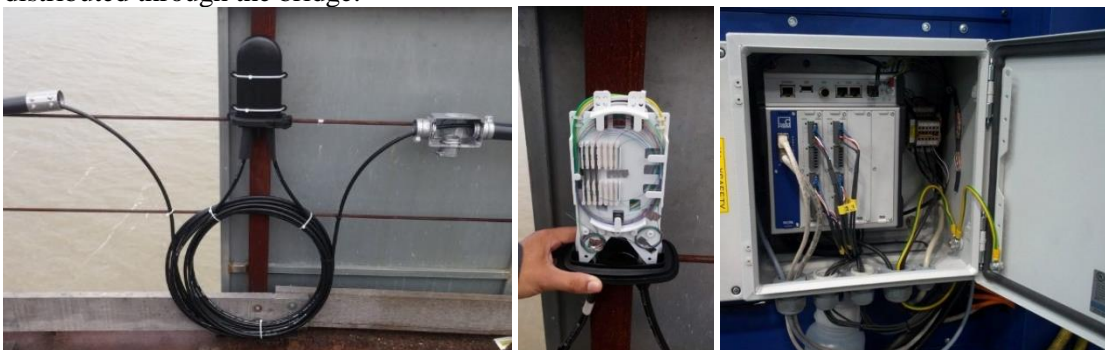
Figure 6. Multi-fiber cable splice protection box (left and center) and PMX device (right).

Between arrays and to the control room, where optical data acquisition systems were positioned, cabled connections were laid via splices, also performed onsite. Multi-fiber cables were deployed along the bridge; on each relevant position, one fiber would be pulled out and connected to the sensor (Figure 6). However, this was not the only function of these cables. The same infrastructure was used as a communication link between the electrical PMX data acquisition systems distributed through the bridge.

The six PMX systems needed were deployed along the structure at the needed locations: on the four provisory structures and on the main towers. Being in the open, equipment like this had to be protected inside proper cabinets (Figure 6).

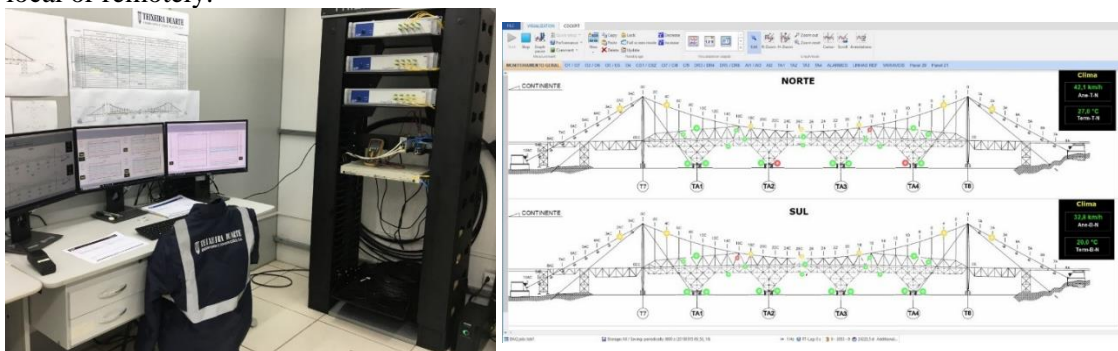
Figure 7. Control room with fully operational monitoring and control system and rack with three Industrial BraggMETER interrogators (left). Example of one of the panels with real-time data visualization over the bridge scheme: Real-time indicators of wind speed and temperature, sensor sections positions, and color status.

All equipment was connected in the control room. All measuring devices were connected through optical Ethernet switches: the PMX from the optical cable and the optical interrogators directly. As mentioned before, six PMX units were used to acquire the 26 electrical signals. For the almost 300 FBG sensors, three BraggMETER interrogators with eight optical channels each were used. All devices were synchronized via catman software and measurement was recorded and processed.

For the overall system, two PCs were used, one dedicated to live and continuous data acquisition and the other to post-processing of previously saved data. The powerful software permits easy data configuration, visualization, storage, and processing, allowing the creation of scripts that automatically create periodic reports and alarms for workers onsite and responsible engineers local or remotely.

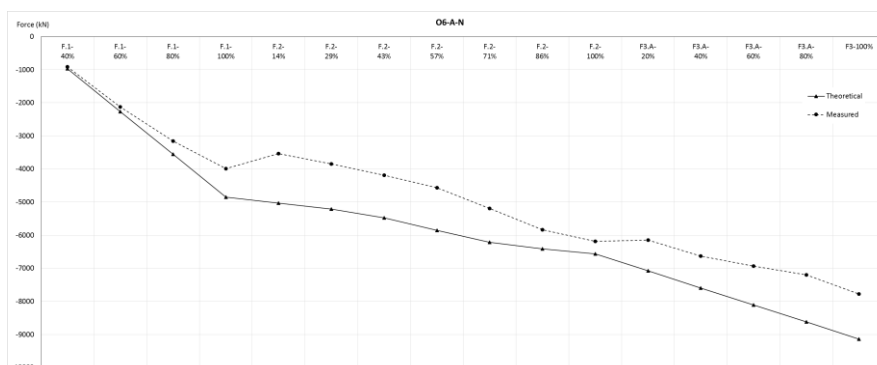
Figure 9. Force measurements at point O6-A-N from Phase 1 to 3.

Besides the analysis during each operation, for some critical sections, a cumulative analysis was studied in order to understand the force evolution throughout time. Figure 9 shows the force evolution of point O6-A-N measured from Phase 1 to 3 in comparison with the theoretical values.

This point corresponds to the eye-bar in the main span that belongs to the catenary. By the end of Phase 3, only some residual force remained in the bars and they could be safely removed.

Each load transfer operation is illustrated horizontally. The force evolution was constructed using the values measured before and after each operation. The stress relieved at each operation was then compared to the theoretical model.

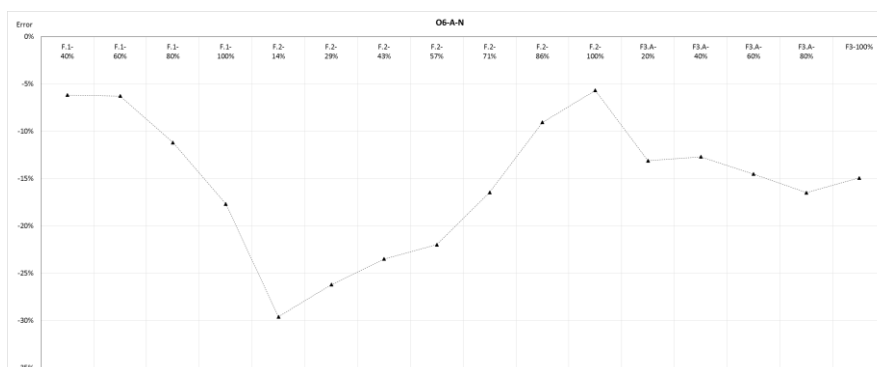
Figure 10. Error evaluation at point O6-A-N from Phase 1 to 3.

Figure 10 represents the deviation between the measured data and the theoretical prediction from Phase 1 to 3 for point O6-A-N. The values observed are within the admissible error initially

defined for this project. Nevertheless, some adjustments of the load transfer procedure were made to ensure safety conditions on removal of the first bars. This reinforces the importance of the monitoring system installed to control the complex operation and working mechanism.
