Test study for full-scale hollow slab girder using UHPFRC reinforcement technology

Lan DUAN¹, Chunsheng WANG¹, Shichao WANG¹, Qian WANG¹, Peijie ZHANG¹
¹ Chang'an University, Xi'an, China

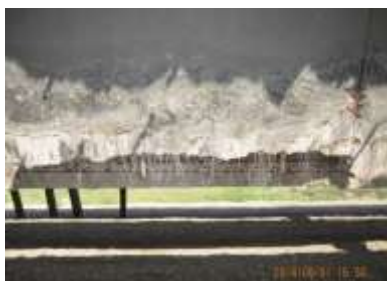
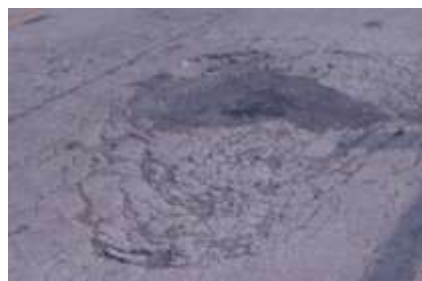
Figure 1. Typical damages in concrete girder bridge.

Typical damages such as concrete cracking, excessive deflection, rebar corrosion and material degradation have observed in concrete girder bridges during the long-term in-service period, resulting in the decline of bridge loading capacity, inadequate safety, or even bridge collapse accidents (Figure 1). The reasons for these damages in concrete girder bridge can be divided into two kinds. The first kind of reason is environmental effect, such as concrete carbonization, chloride salt erosion, alkali aggregate reaction, freeze-thaw cycle damage and corrosion. The second kind of reasons include design and construction factors, such as relatively lower design load grade and material strength in earlier time, improving vehicle load and volume, improper construction, et al. It is necessary to strengthen these in-service concrete girder bridges to achieve structural performance recovery and safety improvement.

(a) Concrete spalling and rebar corrosion

(b) Pavement damage.

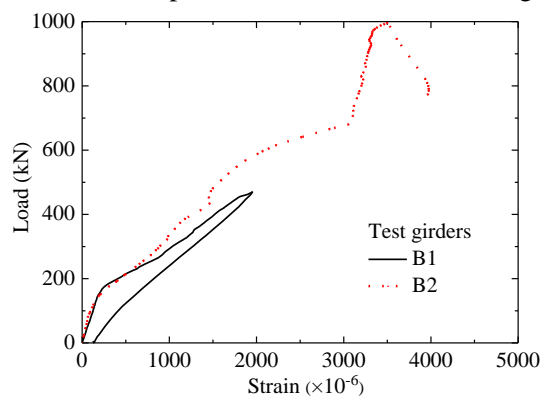
Figure 7 shows the curves between load and strain of longitudinal rebar at bottom plate in mid-span section. Learn from Figure 7, test girder B1 and B2 show linear relationship between load and strain of longitudinal rebar before cracking load. As loading beyond 150 kN, the load and strain curves turn more flat, signifying concrete cracks propagation and strain redistribution period. The strain attained $1955\mu\epsilon$ when loading to maximum load of 469.7 kN for test girder B1, and the residual strain was $128\mu\epsilon$ after unloading. For test girder B2, the rebar began yielding as loading beyond 606 kN, and the strain of rebar at bottom plate did not grow with loading increase anymore as load ranging from 700 kN to 900 kN, because load increase was carried by strands after yielding of longitudinal rebar in original girder and steel plate in reinforcement part. The cross section of test girder B2 turned into plastic at load level of 900 kN.

Figure 7. Load and strain curves of longitudinal rebar in bottom plate.

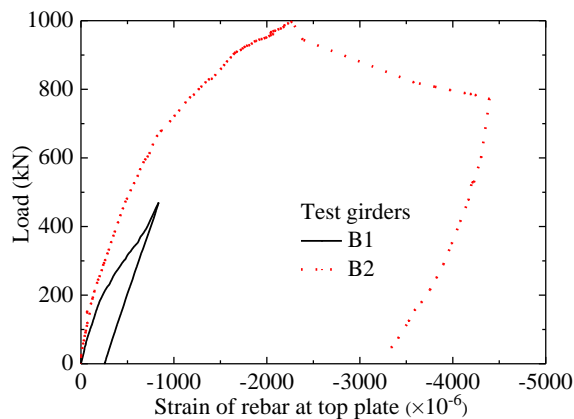
Figure 9 shows the curves between load and strain of rebar at top plate at mid-span section, in which negative value of strain means compressive state. For test girder B1 and B2, there were linear relationship between load and strain of rebar at elastic state. Then, the strain increased with greater rate as concrete at tensile part cracking, rebar yielding or steel plate yielding. For test girder B1, the strain of rebar at top plate increased quickly as loading beyond 180 kN, and the strain of rebar reached $-835\mu\epsilon$ at loading attained 469.7 kN. For test girder B2, when loading above 120 kN, concrete cracking propagated from bottom plate upto web, longitudinal rebar at bottom flange and steel plate in reinforcement part turned yielding, resulting neutral axis moving up and strain of rebar at top plate increasing quickly. The strain of rebar at top plate reached $-2271\mu\epsilon$ as attaining ultimate capacity and decreased to $-4397\mu\epsilon$ after unloading, which signifying fine plastic behavior.

Figure 9. Load and strain of rebar at top plate.
