Damage control, repair and strengthening of concrete arch bridges in China

Baochun CHEN¹

¹ College of Civil Engineering, Fuzhou University, Fuzhou, China

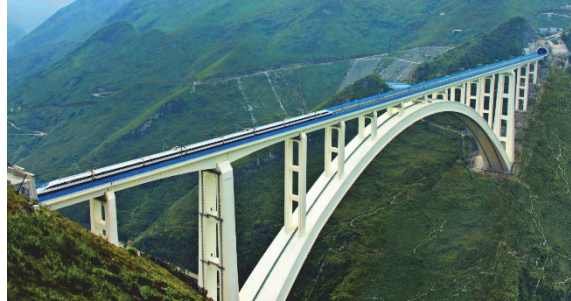
Beipanjiang Bridge, which was opened to traffic on December 28, 2016, is shown in Fig. 1 (Xu, etc., 2011).

Fig. 1 Beipanjiang Bridge

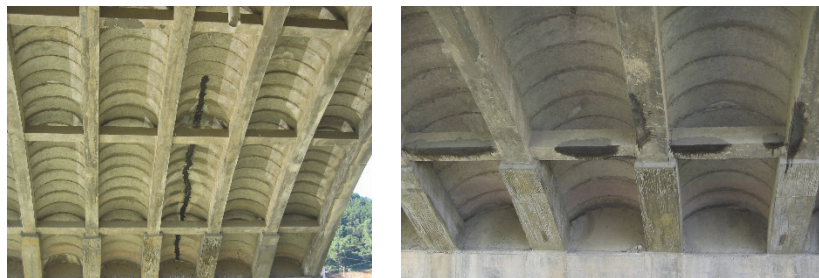
The double curved arch bridge, Wuli Bridge in Fuzhou, built in 1970 with spans of $7.9+8 \times 22+6.1$ m, was taken as a typical example by Shanggun and Zhou (2007). From investigation, it was found that some steel bars in most arch ribs were corroded. The transverse beams were damaged in some sections, and longitudinal cracks appeared in arch ribs, as shown in Fig. 2. After investigation and analysis, repair and strengthening measures were proposed and carried out, as shown in Fig. 3. The arch ring in springing and in crown were both enlarged, the former was enlarged by encasing RC to form a solid section, while the latter was enlarged by adding concrete in saddling to increase the section depth, the soffit of the crown section was reinforced by CFRP.

Fig.2 Damages of Wuli Bridge

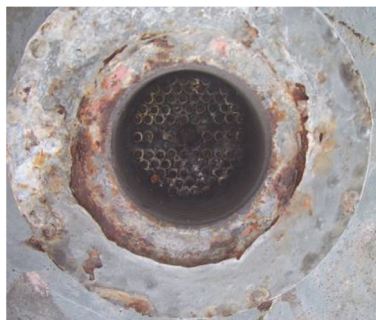
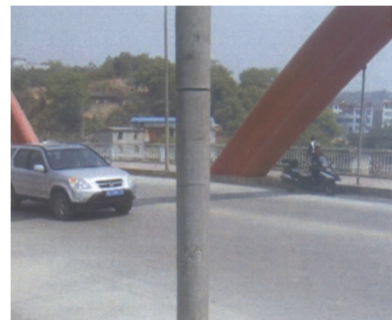
Formerly, most of the concrete arch bridges in China were deck bridges. After 1990, more and more through and half-through arch bridge are built. In these bridges, the dead-load of the deck and live loads on deck are transferred to the arch rib by suspenders. These suspenders are made of high strength cables, in which many problems were detected in existing bridges, such as corrosion, fatigue failure, and insufficient protection, as shown in Fig. 5 (Gao, etc., 2013).

(a) Corrosion in Anchorage

(b) PE Cracking on Suspender Cable

Fig. 5 Distress of suspender

To improve their safety margin, we may use large safety factor for suspenders, enhance the waterproof and anti-corrosion design, employ bolts for the anchor head shields instead of welding for facilitating more easy inspection.

From present engineering practices, the suspender cables do not have the same design life as that of the main structure. Therefore, they must be designated as replaceable components. Moreover, measures for easy replacement should be considered in design, *e.g.*, the old one should be easily dismantled and the new one should be easily installed with a temporary support.

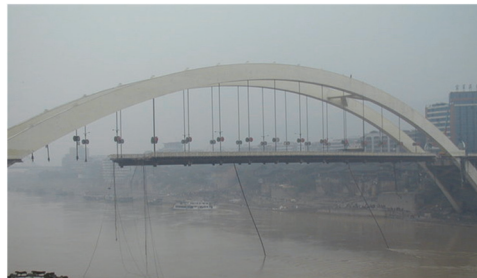
Xiaonanmen Bridge in Yibin City, Sichuan Province, built in 1990, is a half-through RC arch bridge with a clear span of 240 m. There are two arch ribs with a clear rise of 48 m, resulting in a rise-to-span ratio of 1/5. The suspenders are made of steel strands of 21-7 Φ 5 mm, covered by seamless steel tube, filled with cement mortar for protection against corrosion. The suspenders carry the prestressed concrete transverse beams, which support the RC deck slabs. At 4:00 a.m. on November 7, 2001, some suspenders close to the arch springing were ruptured, causing the the transverse beams and deck slabs as well as the passenger car on it fell into the river, as shown in Fig. 6. Four people were killed in this accident.

Fig. 6 Deck system collapse of Xiaonanmen Bridge

In the five bridges above mentioned, the suspenders were protected by steel tubes filled with cement mortar, which are not effective in protection and result the cable vulnerable to corrosion. The suspenders ruptured due to heavy corrosion are the original causes of these accidents.

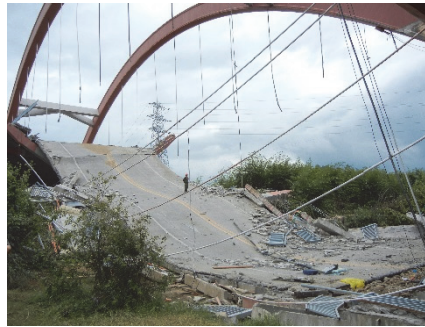
On July 14, 2011, a pair of shortest suspenders in one span was broken when an overloaded dump truck and a passenger bus drove in opposite direction on the bridge. The truck was running towards the midspan and escaped from the bridge, resulting ruptures of total of 7 pair suspenders one after the other, followed by falling off the transverse beams and deck slabs to the river. The bus drove in the direction to the springing, fell into the river (about 8.8 m from the bridge deck to the river bed) together with the bridge deck and transverse beam after they lost the support from the suspenders, resulting 1 passenger killed and 22 injured, as shown in Fig. 7.

Fig. 7 Gongguan Bridge of Wuyishan, Fujian Province

structure, the rupture of the suspender directly result the falling of the deck structure to the river, induce an extent disproportional to the original cause. When there are heavy trucks on the bridge, the stresses of the suspenders are high, which shortened the loss duration and caused large dynamic response to residual structures, and result in other suspenders' failure, thus a zipper-type collapse happen, such as the case of Gongguan Bridge.

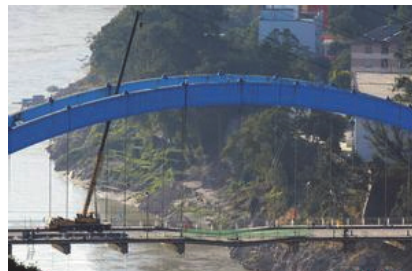
At 6:15 pm of December 10, 2012, a pair suspender slipped out from the bottom anchors due to the anchorage head failure. At that time there were pedestrians and cars on the bridge, but no heavy truck. The failure of the suspenders caused support loss of the transverse beam, and the continuous deck slabs tied to the transverse beam deformed in V-shape but not falling into the river, as shown in Fig. 8.

Fig. 8 Luoguo bridge of Panzhihua, Sichuan
