Structural upgrading of the longest and skewed span of the Yverdon Viaduct

ABSTRACT: The Yverdon Viaduct, built in 1983 and situated in the canton of Vaud, Switzerland, is the object of a refurbishing project aiming to guarantee its remaining service life. The consulting office DIC s.a. ingénieurs in Aigle (Switzerland) was mandated in 2014 by the Swiss Federal Roads Office (FEDRO) to propose a strengthening intervention of the longest and skewed span (73.70 m) of this Viaduct. This span underwent the consequences of a conceptual default (insufficient prestressing) which led to important deformations and appearance of cracks at the lower slab of the multicellular box deck.

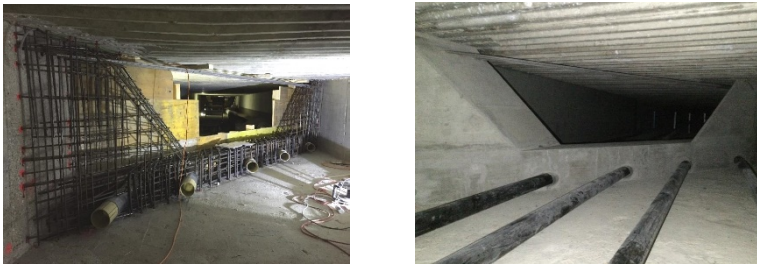
Figure 7. New skewed cross diaphragm, before and after concreting (view from the middle of the span).

The deviation of the cables was realized through new skewed cross diaphragms (figure 7). These elements made of self-compacting steel-reinforced concrete and prestressing bars, transfer the deviation forces of the new cables to the existing structure through their connection with the lower slab and the webs of the multi-cellular deck. The casting took place by pumping the self-compacting concrete through the existing openings for the access of the interior of the multi-cellular box deck. The self-compacting concrete was of strength C35/45, exposure class XC4, maximum grain size D8, flowability SF2 (660-750 MM), degree of compactability C3 and chloride content CI 0.10, according to the Swiss Code SIA 262:2013 for concrete structures.

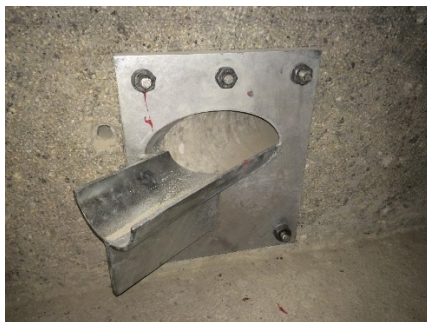
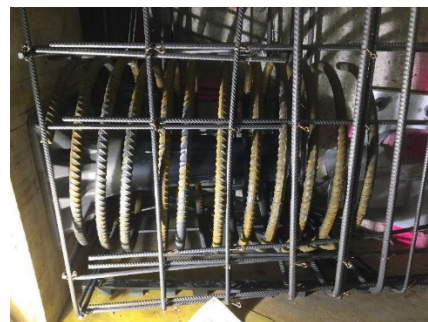
Figure 11. a) Unique steel element made of steel type S235 J2, for the positioning of the anchorage of the post-tensioning cables, b) steel reinforcement detail of the cable anchorage.

The anchoring of the new cables was realized by cast in place self-compacting concrete blocks monolithically connected to the existing skewed crossbeams, as shown in figures 10 and 11.

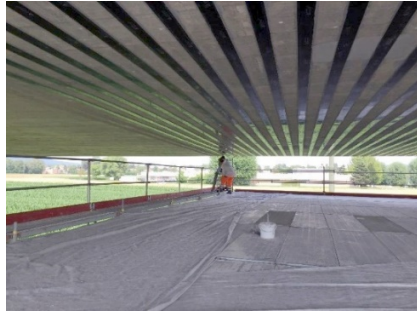
Figure 14. Positioning of carbon fibre reinforced polymer strips (80 mm large, 1.4 mm thick). .

This deficit was compensated by adding strips of carbon fibre reinforced polymer (CFRP), of type Sika CarboDur M814 (Elastic Modulus 205 kN/mm², tensile strength 2800 N/mm², limiting tensile strain 0.065%), in the entire transverse direction of the lower slab for a length of 25 m, about one third of the total length of the skewed main span. This zone extended in the middle of the span and covered totally the area where the tensile cracks were formed with the viaduct in service. Their positioning, three strips per meter, was executed after repairing of the cracked areas and after the prestressing of the new cables. No particular anchorage detail of the bands was needed. The length of the bands is sufficient to activate the needed resisting tensile stress at the required areas.
