Durability Evaluation of Embedded GFRP Rebars in Concrete Bridges after More Than Ten Years of Service

Ali AL-KHAFAJI¹, John J. MYERS¹

¹ Missouri University of Science and Technology, Rolla, USA

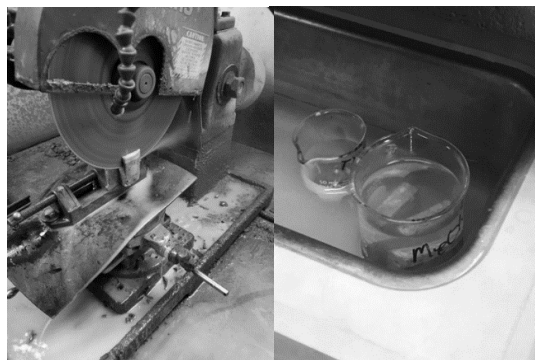
A few cores with a diameter of 102 mm was extracted from each bridge in 2015. Upon extraction, the bridge holes were instantly filled with fast-curing cementitious grout. The total cores extracted from the SV Bridge and the SC Bridge were 20 and 5 respectively. After that, the cores were inventoried at the University of Miami before they (some of them) were shipped to the Missouri S&T for testing. Two cores from the SV Bridge and one core from the SC Bridge were received from Miami University. All the specimens were conditioned before testing in order to obtain realistic measurements and avoid any disturbing factor that could have been introduced during specimens transporting and/or storing. Specimens conditioning comprised of keeping the specimens hermetically sealed and exposing them, in certain cases based on a standard, to solution, temperature, and/or both. Fig. 1 shows specimen's preparations.

Fig. 1: Specimens preparation (A) SEM and EDS sectioning (B) sonic bath

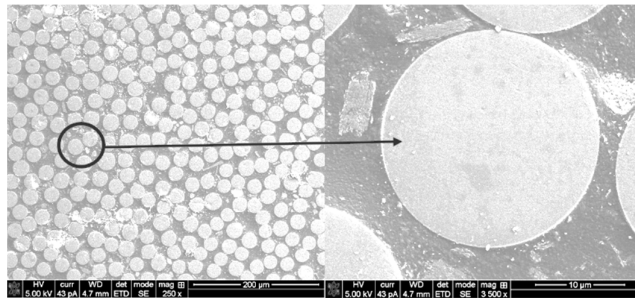
Inside the SEM, different magnification levels were utilized to check for not only the fibers and resin, but also the interfacial transition zone (ITZ) between the GFRP rebar and the surrounding concrete. The SEM results exhibited that there were no signs of microstructural deteriorations in the GFRP's fiber and resin. Also, there was no damage to the ITZ and all the interfaces between the GFRP rebar and surrounding concrete were intact and properly attached to each other. Fig. 2 shows SEM images of the SC Bridge.

Fig.2:SEM image – X250 and X3500

In order to check for microstructural deteriorations, a Helios Nanolab 600 SEM device was selected to conduct the test. Two specimens with no more than 25.4 mm diameter and less than 13 mm thick were used to perform the test. Before using the SEM device, the specimens were prepared and conditioned. The preparation involved smoothen the surface by using several grades of sand papers and then polishing. After preparation, the specimens were placed inside an oven for 2 days at 40°C to get rid of any access moisture as part of the specimens conditioning. After the two-day oven exposure, a gold coating was applied on the specimen's surface in order to obtain a better backscattered electron reaction and thus a better quality image can be gained from the SEM device.

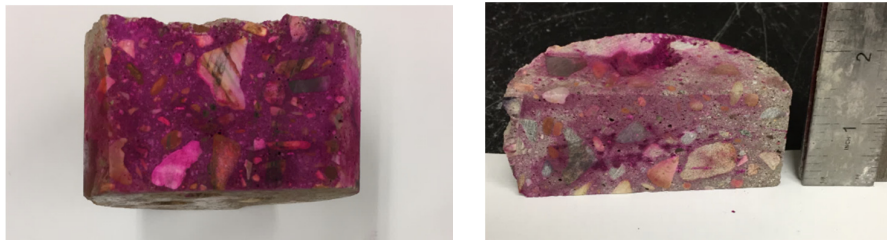
Concrete cover protects steel reinforcement in RC structures from corrosion. The cover, though, is exposed to carbon dioxide of the surrounding atmosphere. When the carbon dioxide reacts with the alkalis in the concrete, concrete pH falls down. As a result, the alkalinity level in concrete will be reduced and expose the concrete to carbonation attack. It has been proposed that corrosion takes place when the depth of carbonation is equal to the concrete cover. To conduct the test, RILEM-94 (RILEM and Materials, 1994) was implemented where 1% of phenolphthalein was added to a 70% ethyl alcohol solution to form a solution used as an alkalinity indicator. The solution was sprayed to a fresh cut of the concrete core's surface. Next, an observation was made to the color of the surface, if the surface's color turned from concrete grey color to purple, it indicates there is no carbonation attack as the medium is alkaline. The darker the purple color is, the more alkaline the medium is. The results showed that for the SV Bridge, there were no signs of carbonation attack. However, in the SC Bridge, a carbonation depth of 13 mm to 25 mm was observed. Fig.4 shows the results of the carbonation depth test.

Fig. 4: Carbonation depth test (A) Southview Bridge (B) Sierrita de la Cruz Creek Bridge

- SEM showed no signs of degradations.
- EDS exhibited no signs of chemical elemental changes.
- SBS results were in match previous tests results (same rebars but different cores).
- Fiber content results showed no signs of fiber loss and were in match with the previous tests results (same rebars but different cores).
- pH levels within the normal range, between 11 and 12.
- Carbonation depth was present with a depth between 13 mm to 25 mm.
- Chlorides content was insignificant.
