Acoustic monitoring of a prestressed concrete beam reinforced by adhesively bonded composite

1 DESCRIPTION OF THE PROJECT “CLERVAL”

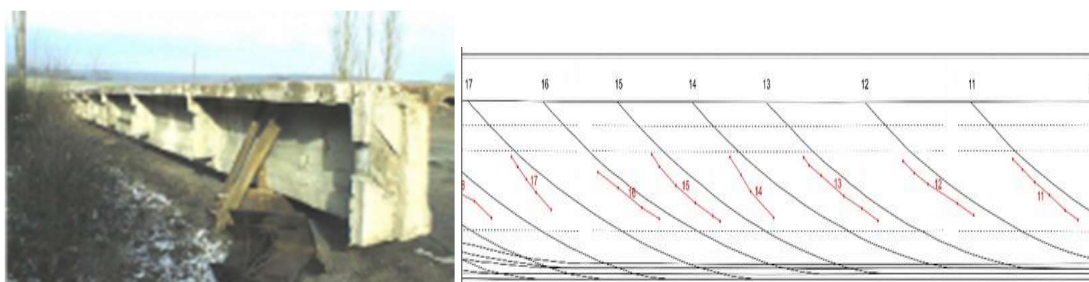
The used prestressed concrete beam comes from a viaduct over the river Doubs at Clerval that was erected between 1952 and 1954 and demolished in 2002. This beam was 30 m long and 1.3 m high and it had two initial bend cracks with a maximum opening of 0.2 mm (sections S2 and S4). Prestressing cables are not straight and their position is not symmetric (figure 1). The prestressing system is STUP 12 Phi5.

Figure 1. Photo of the studied beam and scheme of the prestressing cables position on one side of the beam
