Full scale cast iron girders reinforced with CFRP - flexural testing

ABSTRACT: This paper will report on the flexural testing of two cast iron girders from a demolished railway bridge in Scotland. The girders were 151 years old and had been reinforced with ultra high modulus carbon fibre polymer composite (CFRP) in 2004. The CFRP on one girder had been damaged during the demolition and was rendered completely ineffective before testing. The girders were 9m long and were tested in four point bending to failure giving a unique opportunity to compare the behaviour of unreinforced and reinforced cast iron at full scale. After the flexural testing fragments were tested to obtain material properties. The tests showed the considerable benefits of CFRP strengthening and confirmed that the CFRP was fully bonded to the cast iron until close to the point of failure. The test results have been compared to the original design predictions. The paper will include details of the girders, the test rig and procedure and will discuss the benefits obtained from CFRP strengthening of cast iron girders.

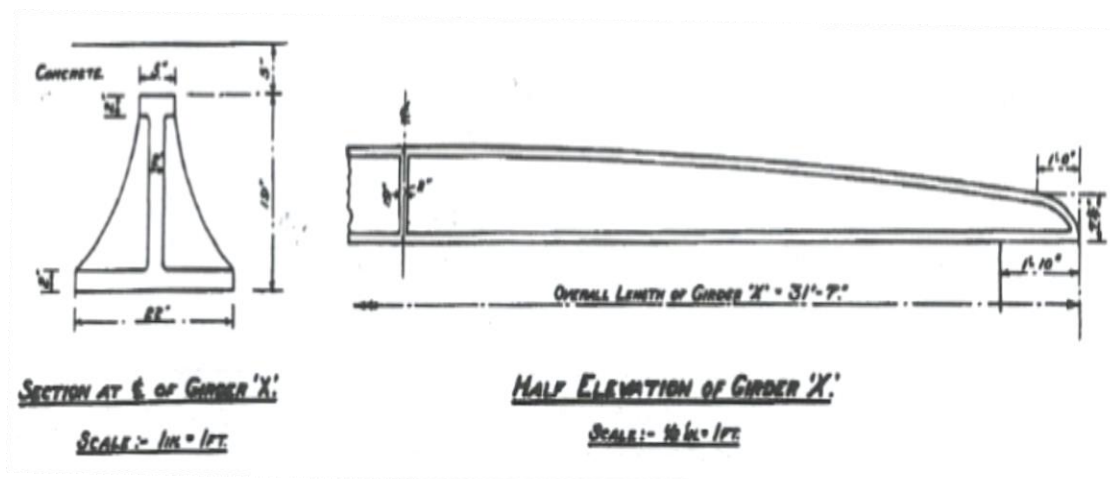
Figure 1. London Midland and Scottish Railway drawing showing cast iron girder details.

In the 1800s girders were cast in sand moulds and the cast iron in large girders presents various problems: blow holes up to 10mm diameter, cold joints due to disruptions during casting, contamination from sand that detached during casting, large variations in section dimensions and differential cooling resulting in distortions in section geometry and residual stresses.

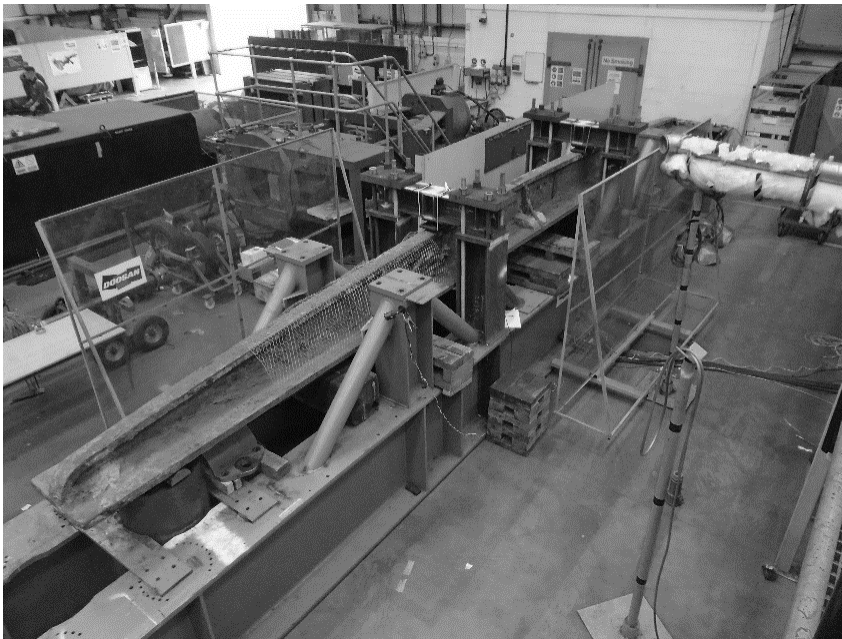
Figure 2. Girder in four-point bending rig (courtesy Doosan Babcock Limited).

Figure 2 shows the test rig with a girder in position. The simply supported span of the girder was 8.49m. The rig was unusual in that hydraulic jacks applied upward forces at the ends of the girder with the specimen held against reaction frames at the third points. Doosan Babcock had to modify their standard rig to accommodate the specimens. Four-point bending gives constant bending moments and zero shear force in the middle third of the specimen and high shear forces and varying bending moments in the rest of the specimen. Network Rail assessments of the girders had shown adequate shear capacity so flexural failure of the girders was anticipated. However, the depth of the cast iron varied along the length so flexural failure would be expected close to the interior reaction points but the combination of high shear and bending moment just outside the middle third meant that the failure location could not be predicted in advance.

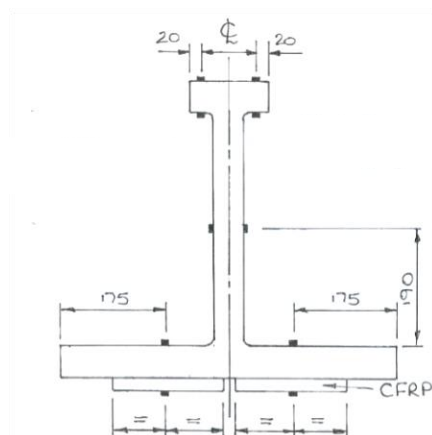
Figure 3. Strain gauge locations near mid-span, all 30mm gauge length

Girder 2 was reinforced with CFRP nominally 14mm thick. It consisted of 3 layers of Ultra High Modulus CFRP plates each 4.7mm thick. There were two sets of plates, each 200mm wide, located on the tension flange. There was also a thin layer of GRP between the cast iron and the CFRP to insulate the CFRP from the metal. All plates were bonded together and to the CFRP using epoxy adhesive. The adhesive layer between the CFRP and the cast iron was nominally 2mm thick. The girder was heavily instrumented; displacements were measured as before and strain gauges were located close to midspan (see Figure 3) and close to one end of the CFRP.

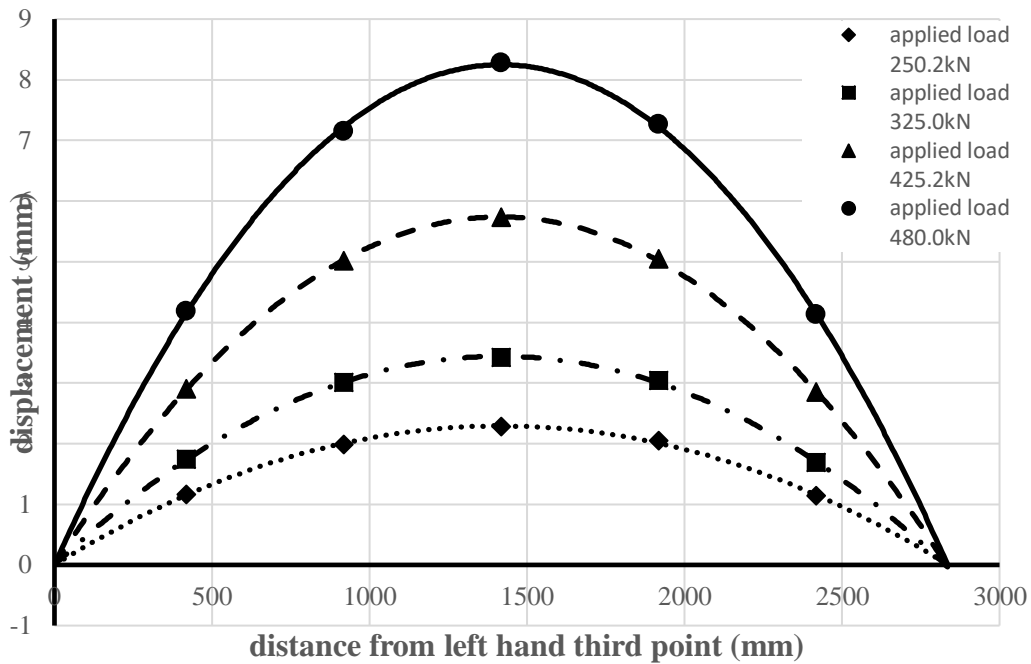
Figure 6: Flexural displacements, girder 2.

When displacement transducer readings were plotted against applied load a limitation of the test rig became apparent. The measured deflections were a combination of overall bending, bedding-in of the distorted flanges and the displacements of the test rig. Careful analysis enabled the overall deflections at higher loads in the constant moment length to be separated out and typical flexural displacement plots for the reinforced girder are shown in Figure 6. Load-maximum

flexural displacement plots are shown in Figure 7. Using the slopes of the graphs in Figure 7 as measures of stiffness, the reinforced girder was 53.5% stiffer. The maximum flexural displacement of girder 2 was 8.3mm in the central third which extrapolates (theoretically) to 70.4mm over the full span.
