Structural Health Monitoring of Bridges in Mexico – Case Studies

ABSTRACT: Three case studies of Structural Health Monitoring (SHM) of bridges in Mexico are documented in this paper. Firstly, the SHM of the Papaloapan Bridge is presented. For this case study, the SHM was designed and installed for the structural assessment of this cable-stayed structure after two failures and loosening of its cables. Secondly, the structural assessment of El Carrizo Bridge is reported. Such a bridge has a box girder cantilevered structure section that was damaged after a fire provoked by an accident of a vehicle transporting Diesel. In this case, the SHM system was installed to control the overall rehabilitation of the bridge. Finally, a probabilistic SHM strategy for a reinforced concrete bridge is documented. The probability of failure is calculated evaluating displacements obtained via Global Positioning System (GPS) technology. Based on the results presented in this paper, the SHM of bridges in Mexico has been validated to be a useful and a cost-effective tool, not only for evaluating critical conditions and rehabilitation, but also for future structural integrity and prognosis of bridges.

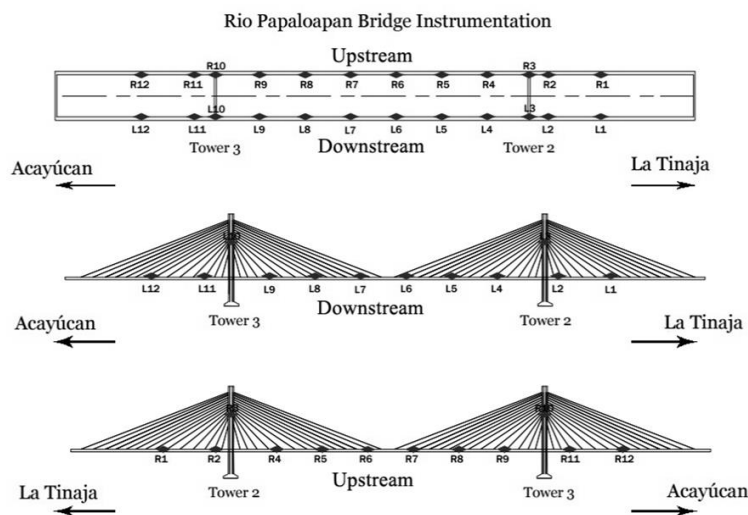
Figure 4. SHM Distribution diagram for the Papaloapan Bridge.

The SHM system for the Papaloapan Bridge was based on fiber optics sensors. Such a SHM system has 24 strain gauges, 24 accelerometers, 1 displacement sensor, 8 tiltmeters and 5 temperature sensors. The SHM system was energized with 96 photovoltaic solar cells, 36 deep cycle batteries and their controllers. The local monitoring system included a FO interrogator, 1 multiplexor and one computer. Additionally, the SHM system included 2 video cameras, one weather station and one seismological station. The SHM system is currently communicated via satellite to the monitoring center for bridges and intelligent structures in the Mexican Institute of Transportation. The sensors were distributed to analyze the dynamics of the bridge deck and the two towers, respectively. Thus, the strain gauges were located in the next way: 10 under each one of the main girders of the bridge deck, and one on the side at half height of each tower. Also, on the top of each one of the four towers, 2 tiltmeters and 2 accelerometers were fixed. The other 16 accelerometers were placed on the middle of cables 4 and 11 of each semi-harp (see Fig. 4).

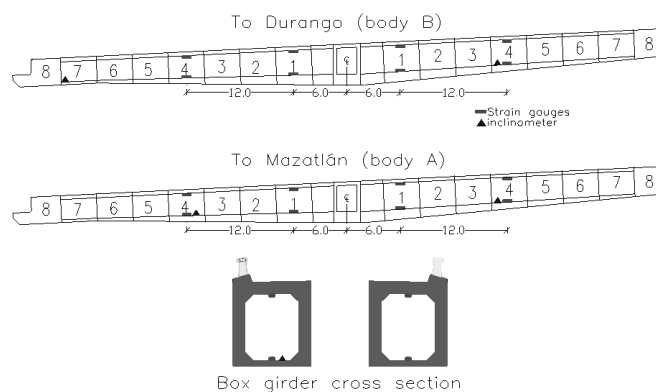
Figure 5 – SHM for permanent monitoring during rehabilitation.

The SHM system for El Carrizo Bridge was designed considering only the damaged double cantilever structure section of the bridge. The continuous monitoring instrumentation was made up of strain gauges, tiltmeters and temperature Fiber Optic Sensors (FOS) as illustrated in Fig. 5.

The FOS system included 16 strain gauges located inside both box girders on the upper and lower sides, 4 tiltmeters and 4 temperature sensors, two on each side, as indicated above in Fig. 5. This temporal monitoring system was placed during load testing. Such a temporal sensor system involved 20 strain gauges, which were placed inside both box girders on the left and right sides, and 2 LVDT sensors at the end of the cantilever section that is connected with the cable-stayed structure. Monitoring system purposes were to evaluate continuously in real time the rehabilitation process and provide information to calculate the rating factor.
