Warren Hall Seismic Retrofit vs. Demolition – A Feasibility Analysis - Case Study

ABSTRACT: This is a case study about the demolition of a 13-story concrete and steel building named Warren Hall located on California State University, East Bay campus Hayward, California. The case study covers the study of vulnerability of the building, which posed life threats to the occupants, structural deficiency when subjected to lateral forces, the proposed seismic retrofit systems to strengthen the building and the other selection of alternatives, and the final demolition decision and the demolition of the building.

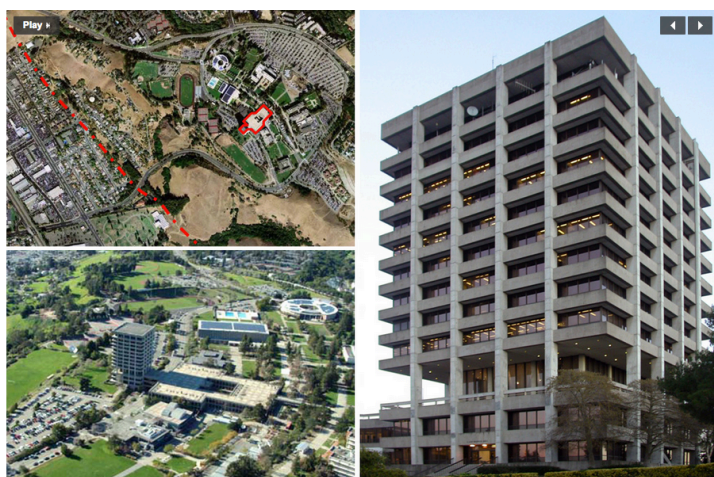
Figure 1. Location of the Hayward Fault and the Warren Hall

The section of the Hayward Fault that runs near the University is presented in Figure 1. The Warren Hall was built approximately 600 meters from the Hayward fault on a hill. This building was one of the most seismically unsafe buildings in the Bay Area. The USGS estimates that there is a 63 % chance of a major earthquake in the Bay Area within the next three decades.

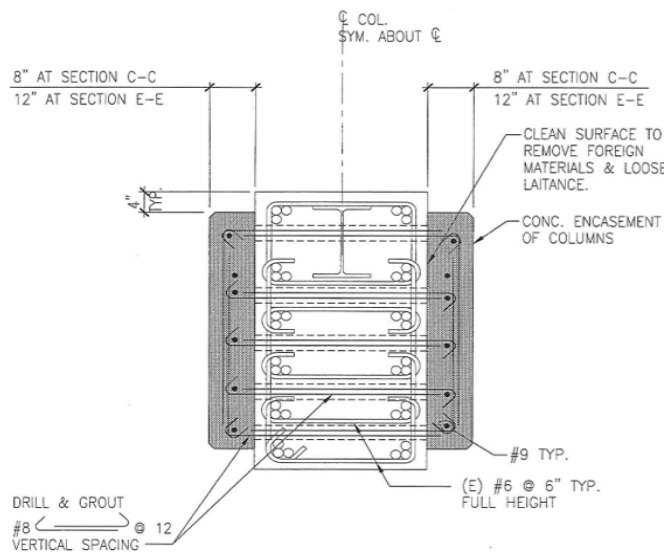
Figure 2. A typical Section of Column Enlargement by Reinforced Concrete Encasement

Column encasement through the joint region with reinforced concrete increases the beam-column joint effective area and allows for joint horizontal shear reinforcement to be added. The full height column enlargement increases column flexural and shear capacities. This supports conventional strong-column/weak-beam strength hierarchy, mitigates column flexural yielding, and prevents premature column failure. A typical section of the column enlargement by reinforced concrete encasement is shown in Figure 2 below.

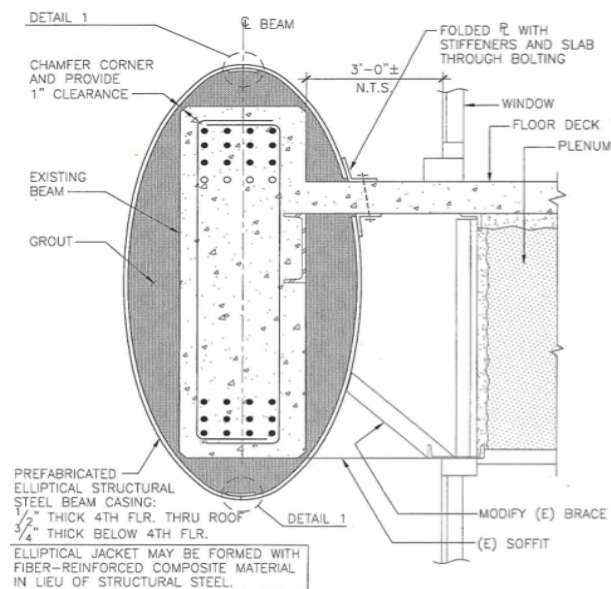
Figure 3. A typical Section of Elliptical Steel Jacket Encasement.

The elliptical casing contributes to the beam shear capacity, thus preventing premature beam shear failure and loss of vertical load carrying capacity. In particular, the casing prevents the tendency for the shear failure at termination points for groups of longitudinal reinforcement. A typical section of the Elliptical Steel jacket encasement of beam is shown in Figure 4 below.

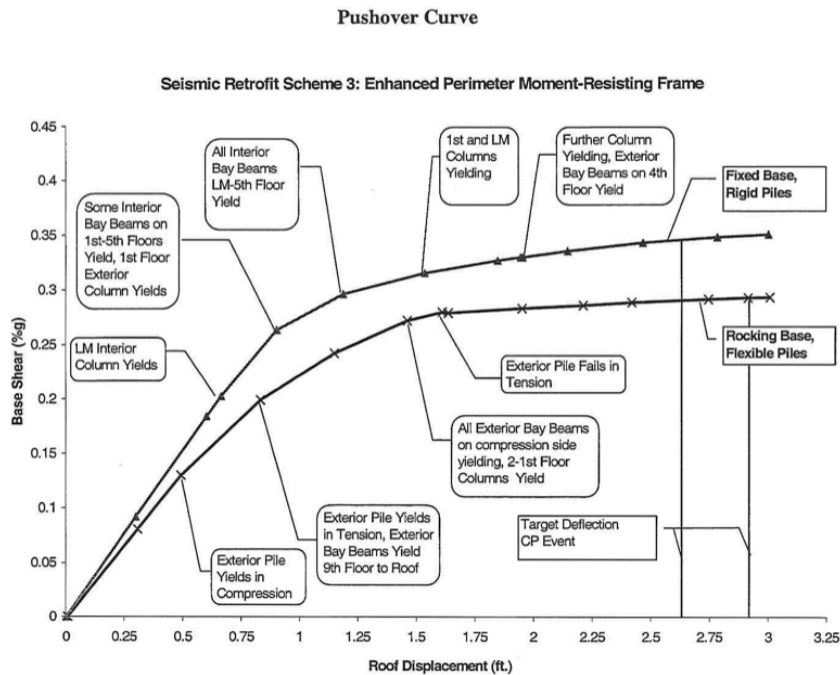
Figure 4.

With these retrofit components in place, the pushover curve for the building was analyzed. The result of elliptical beam jackets and concrete encasement in flexural hinges, being the element yielding mechanism, is shown in the Figure 4 below. It is also shown that they provide sufficient ductility for the target displacement to be attained with premature failure.
