Remote Monitoring System for Road Condition Assessment and Its Application

ABSTRACT: This paper introduces a newly developed road pavement condition assessment system (called “Ippo-Campo”) that can be used to perform a visual assessment of the condition of not only the pavement but also the road structures such as appurtenances, slopes and vegetation, and its practical application to road maintenance decision-making. Ippo-Campo is a road pavement maintenance evaluation system based on a moving vehicle and obtains data from a motion sensor, moving vehicle video, sound and GPS data. It is a simple evaluation system that provides a systematic, consistent approach to the evaluation of the condition of a road pavement surface. In addition, the video file produced by Ippo-Campo can be used for making a multi-criteria-based decision. In this paper, it also makes practical applications the system to the Mine-city road network in Yamaguchi Prefecture, Japan for confirming the effectiveness of the system.

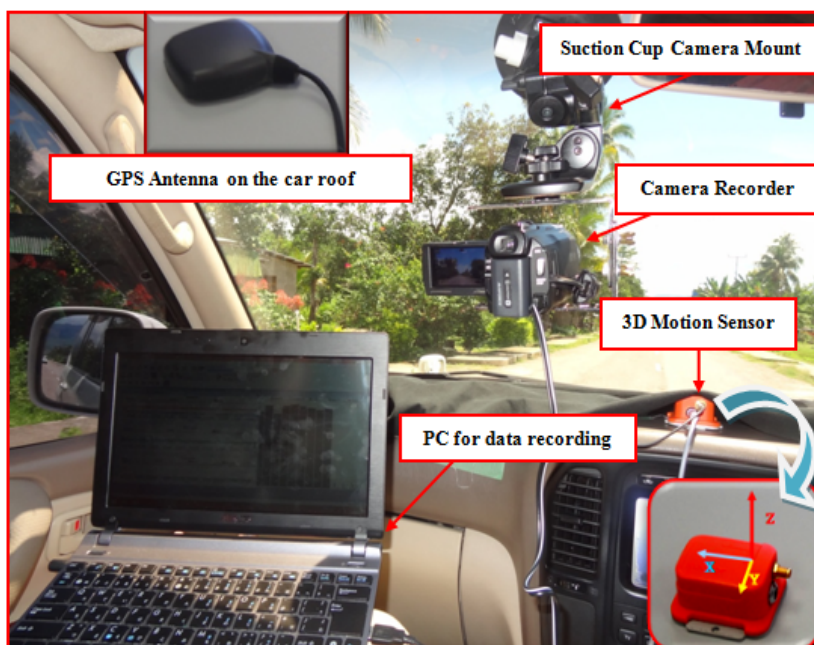
Figure 1. Arrangement of measuring equipment installed in a car.

This section briefly overviews how data analysis is performed. Data are obtained using a three-dimensional motion sensor combined with a GPS system with a gyro and acceleration sensors. Fig. 1 shows the equipment installed in a vehicle. It takes about 20 min to install and start-up the measuring equipment. The system sensor acquires GPS log data. Thus, the acceleration, time (GMT), angular velocity, geomagnetic and orientation sensor information, orbital plan view and satellite reception conditions can be recorded. The time in GMT is very important to the synchronizing of the video information with the sensor information. In addition, items displayed on this screen can be selected independently; the scale of the viewing area is arbitrary [Miyamoto et al. (2013)]. Fig. 2 shows an example of the system's signal display. The noise from the car and the car's motion data, as obtained from the video and the motion sensor are obtained from a car travelling along a selected road. The recommended speed of the car is 50 km/h to 60 km/h. It is possible for one person (the driver) to check the status of the installation of the equipment and capture the data [Hugo et al. (2014)].

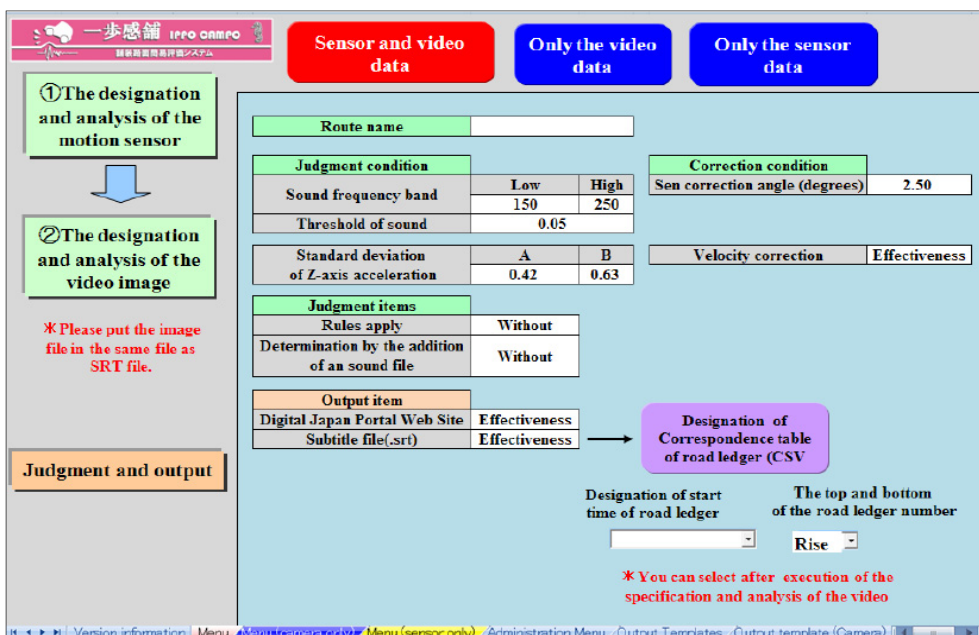
Figure 3. Menu screen of the road condition assessment system.

An evaluation of the road pavement condition using the Ippo-Campo assessment system and the obtained three-dimensional motion sensor data, video data and sound data involves several steps. Fig. 3 shows an example of the system’s menu screen. It was developed using the Visual Basic application from Microsoft Excel [Miyamoto et al. (2013)]. Fig. 4 shows the configuration of the functions of the system. Motion sensor data, driving video data, sound data,

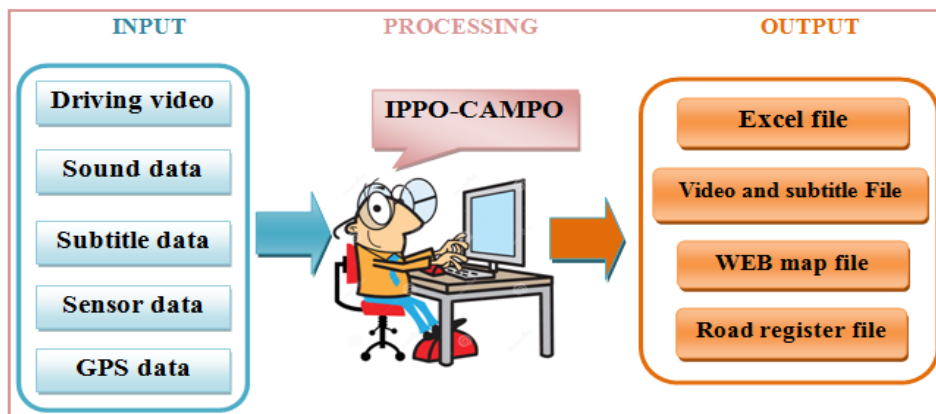
Figure 4. Configuration of the system functions.

subtitle data and GPS data are acquired by the system. By connecting these data, an evaluation of the road surface is output per second of longitude, latitude, X and Y coordinates, point distance, etc. to Excel as “good”, “moderate” or “bad”. In addition, by linking the system with online maps by using the GPS data, the evaluation results can also be displayed on a map. Then, by converting the world geodetic system into latitude and longitude information, it is possible to reflect the results of the evaluation on the road register map data [Hugo et al. (2014)].

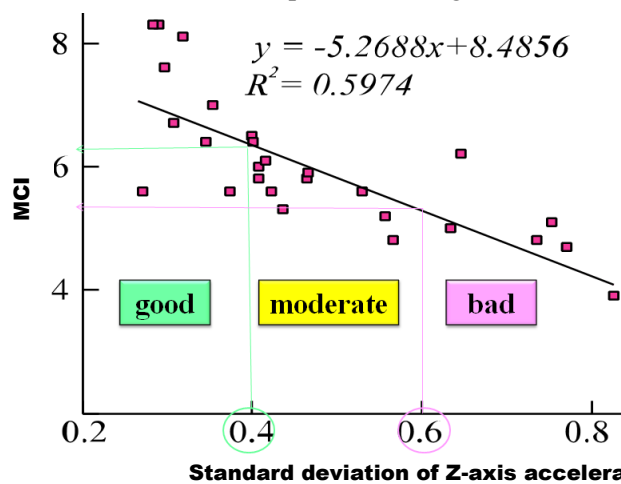
Figure 5. Correlation of MCI and the standard deviation of Z-axis acceleration.

The determination of the threshold points for the pavement surface uses the standard deviation of the Z-axis acceleration rate signal. The threshold was decided by conducting a road surface measurement test as part of a cooperative study undertaken by Yamaguchi Prefectural Government and Yamaguchi University. The defined value was obtained by evaluating the data between the MCI and the Z-axis acceleration. The results assumed that the threshold level for pavement management for the standard deviation of the Z-axis acceleration is described as: 0 to 0.4 is “good,” indicated in green and with the ○ symbol; 0.4 to 0.6 is “moderate,” indicated in yellow and with △ symbol; and more than 0.6 is “bad,” indicated in and with the × symbol. Fig. 5 shows the correlation between the MCI and the standard deviation of the Z-axis acceleration. The regression equation and correlation coefficient are derived from the relationship between the MCI standard and obtained data for the Z-axis acceleration. It is assumed that the value of 0.4 for the standard deviation of the Z-axis acceleration is equivalent to ≥ 6 for the MCI that represents the “good” condition of the road pavement. A value of 0.6 for

the standard deviation of the Z-axis acceleration is equivalent to ≥ 5 for MCI and represents the “moderate” condition of the road pavement. Moreover, a value of ≥ 0.6 for the standard deviation of the Z-axis acceleration is equivalent to ≥ 5 , corresponding to the “bad” condition of the road pavement [Hugo et al (2014)]. Table 1 shows an example of the output data from an excel file. And Figs. 6(a) and (b) show an example of video and subtitle file which illustrates the situation of road by showing the sub title data through the movie file (Fig. 6(a)) and an example of output data which shows the condition of the road trough web map data in which illustrates in 3 highlighted colors, red as a bad condition, yellow as moderate and green represented the good condition as mentioned above (Fig. 6(b)), respectively.

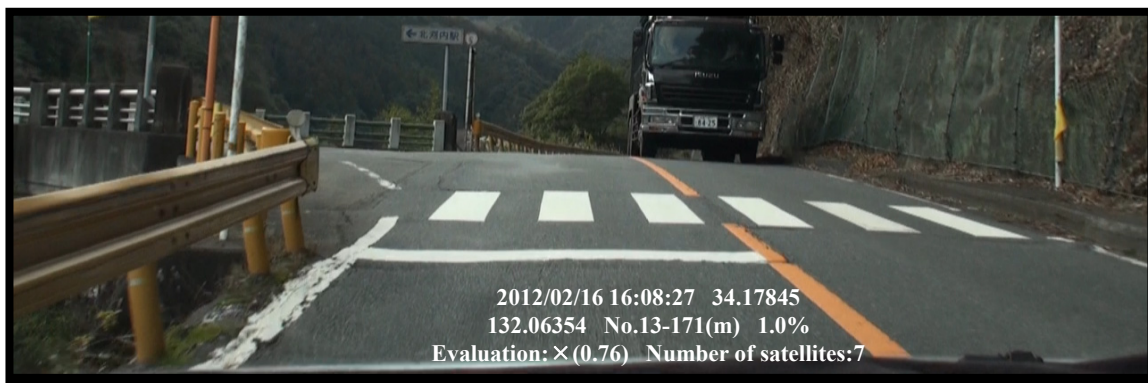
Figure. 6(a) Example of evaluation results using movie file with subtitle.

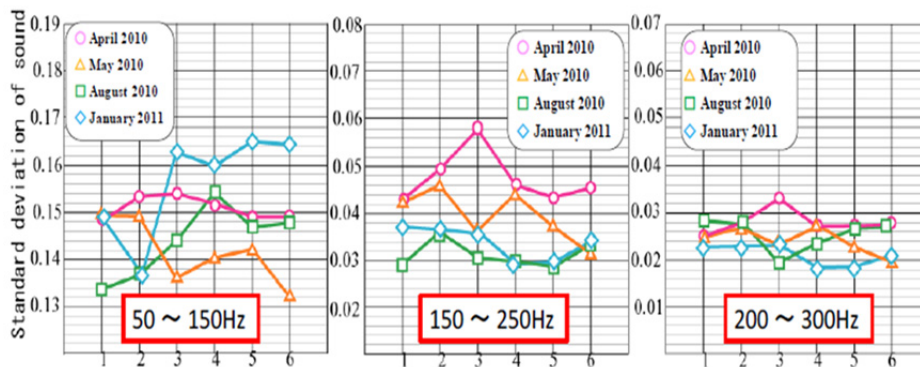
Figure 7. Standard deviation of sound of running vehicle by frequency band.

The evaluation signal consists of two standard deviations, sound data, and acceleration data. It is obtained by analyzing the relationship between the standard deviation and the sound data for the road surface. The sound data was obtained by running a sound test in the test car. The movement of the car along the road resulted in road noise at 20 to 20,000 Hz. The frequency band of the road noise produced when traveling over a road surface with an irregular roughness was around 10 to 1000 Hz. Therefore, to analyze the frequency band representing the condition of the road surface, the sound data at 10,000 Hz was divided by a sound band-pass filter (BPF). Fig. 7 shows how the band is partitioned into three parts, especially 50 to 150 Hz, 150 to 250 Hz and 200 to 300 Hz. The data for 50 to 150 Hz and 200 to 300 Hz are not suitable for use as a sound evaluation signal [Miyamoto et al. (2013)]. However, the sound data for 150 to 250 Hz is suitable for use as an evaluation signal because it is clearly discernible despite having different values before and after the pavement repair works [Hugo et al. (2014)]. Meanwhile, the evaluation signal for the acceleration data was also obtained. Fig. 8 shows the standard deviation of the acceleration using three-axis vehicle vibration data. It illustrates that the X and Y-axis accelerations are not suitable for use as an evaluation signal. However, the Z-axis acceleration is suitable for use as an evaluation signal because it is clearly discernible despite having different values before and after the pavement repair work.

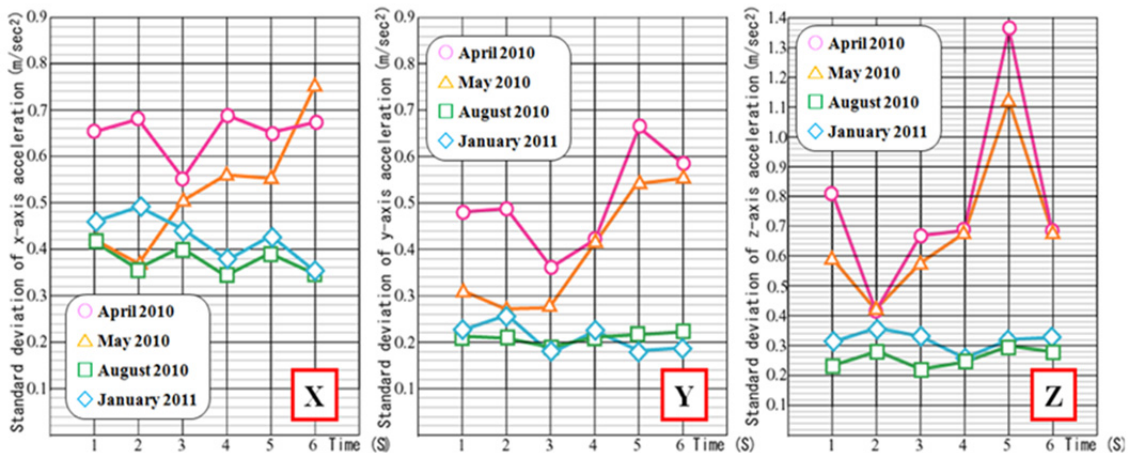
Figure 8. Standard deviation of the acceleration obtained from vehicle vibration data.

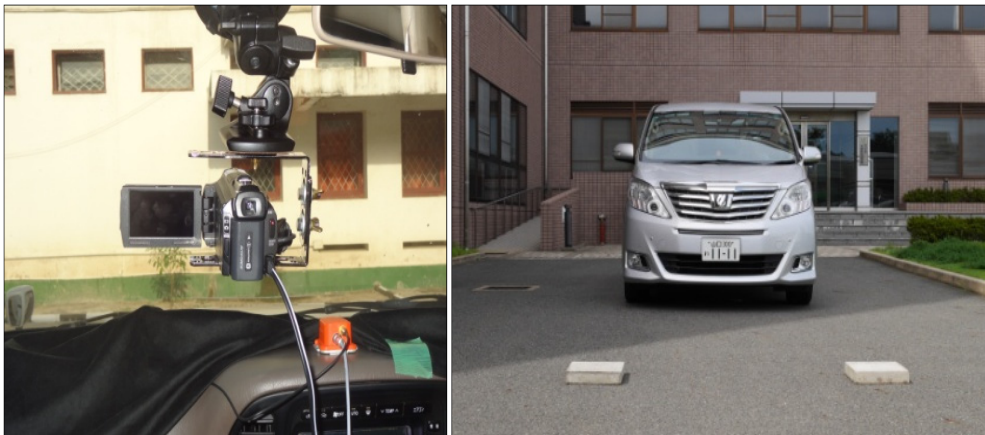
Figure 9. Set up in measurement vehicle.

The dependent velocity of the system was determined by evaluating the velocity change of a vehicle while in motion to determine the evaluation signal influence. The study was conducted on a public road by using a vehicle to drive over concrete blocks placed in front of both front wheels, as shown in Fig. 9. This examination was performed to obtain the data for the pavement surface by changing the velocity of the vehicle. Starting with a velocity of 5 km/h, the velocity range of the examination was 20 to 50 km/h over a distance of 30 m [Hugo et al. (2014)]. Fig. 10 shows the result of the examination. It shows the relationship between the velocity and the standard deviation of the Z-axis acceleration in the evaluation signal. The data illustrates that the standard deviation of Z-axis acceleration (y) increases with the running speed of the vehicle (x). Therefore, the regression equation and correlation coefficient were derived from the relationship between the evaluation signal and the velocity, defined as follows [Miyamoto et al. (2013)].
