Diagnosis, assessment and structural restoration of the Royal Palace of Naples

F.M. Mazzolani¹, B. Faggiano¹, A. Marzo¹ and M.R. Grippa¹

¹ University of Naples "Federico II", Dept. of Structural Engineering, Naples, Italy

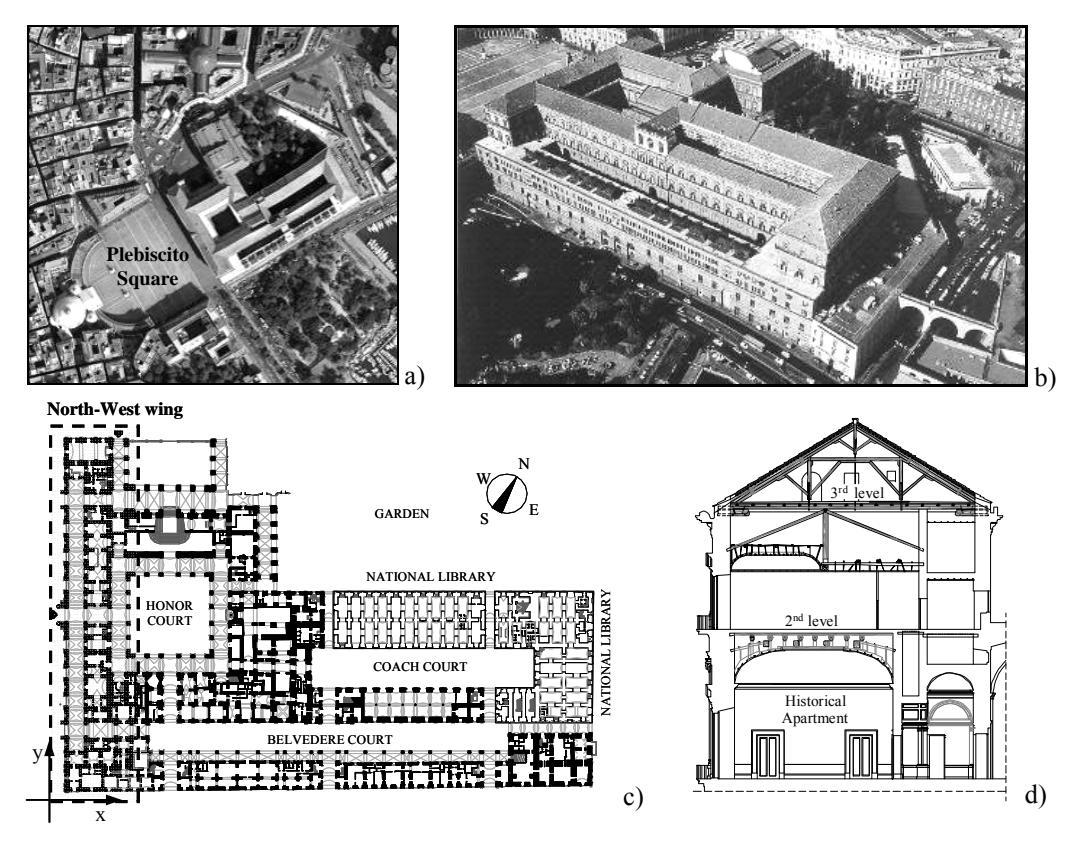
Figure 1. The Royal Palace of Naples: a) Plan Overview, b) General view; c) Ground floor layout; d) Typical structural section.

The Royal Palace of Naples is located in the historical centre of the town, in Plebiscito Square (Figs. 1a,b). The square body which encircles the Honour Court was built between 1600 and 1613; it corresponds to the original design by the architect Domenico Fontana (1543-1607). During time the original layout of the Palace has undergone several transformations, due to both royal needs and static demands, finally achieving the today's configuration (Fig. 1c). The building has been Royal Palace from 1600 to 1946; actually it houses the Museum of the Historical Apartment, the National Library and the Superintendence to architectural heritage offices (Mazzolani et al., 2008).

The Palace is characterized by a complex layout both in plan and in elevation (Figs. 1c,d). The building is articulated on three main levels with vertical structures made of tuff masonry walls and horizontal ones composed by either beam floors and vaulted ceilings or tuff masonry vaults (Fig. 1d). The roof structures are realized by trusses and tiles. All the trusses were originally made of timber, but some of them, due to the weather degradation occurred during time, have been recently substituted by either reinforced concrete, steel or glued laminated timber trusses. At the 3rd level there are horizontal timber beam floors; between the 3rd and 2nd floors there are generally false ceilings, realized by both timber vault and in plane grids partially suspended to the floor above; at the 2nd level both masonry barrel vaults and timber structures are realized (Fig. 1d). In particular, the halls of the Historical Apartment, which is located at the first floor of the noble part of the building, around the Honour Court, have complex timber roofing structures (Faggiano et al., 2008; Marzo et al., 2009; Mazzolani et al., 2010).

For the building under study all the significant parameters were calculated based on the following assumptions (Mazzolani et al. 2009): the ultimate shear strength is referred to the y in plane direction only (Fig. 1c), because in the x direction the model is affected by lacks of approximation, considering that the NW wing of the Palace has been isolated from the rest of the overall constructions; according to the national seismic zonation (D.M. 2008), the Palace is located in zone 2 with a soil type B; the seismic hazard of the site was referred to the detailed national seismic hazard maps (OPCM, 2006), therefore a_g and S are equal to 0.175g and 1.25 respectively. In this condition, the weak plane is the first floor (see Table 2), the corresponding collapse peak ground acceleration being equal to 0.11g, which is the smaller one as respect to the other floors.

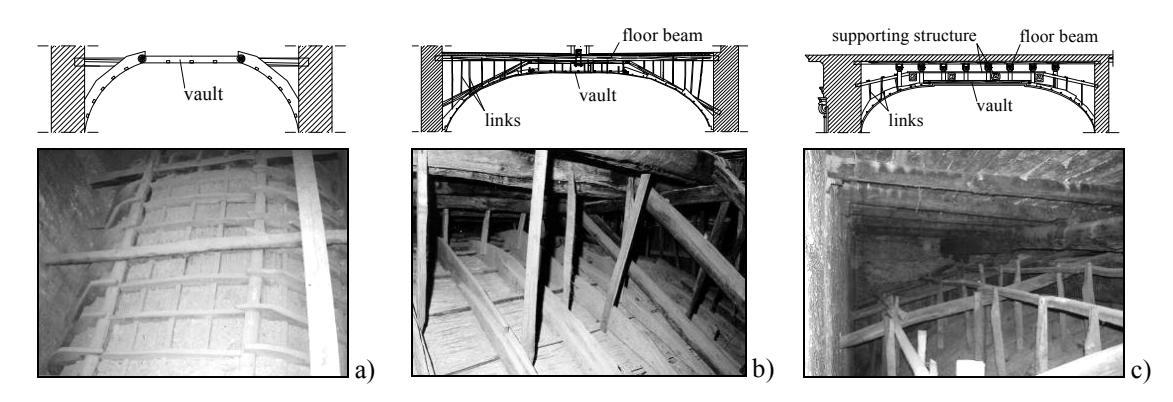
Figure 2. The timber roofing structures of the Royal Apartment: a) Type 1; b) Type 2; c) Type 3.

Most of the halls of the Royal Apartment are covered by complex timber structures, datable between the XVII and the XVIII centuries, generally composed of two superimposed subsystems, such as the beam floor and the vaulted ceiling. During the surveys, three different structural types were detected (Fig. 2), consisting in self-bearing vault, where the spans between the perimeter masonry walls are up to 4.00m (type 1) and, for spans more than 4,00m, in vault

connected by wooden links either to the floor beams above (type 2) or to an "ad hoc" supporting structure independent from the floor (type 3, Mazzolani et al., 2010).

The vault timber skeleton is made of a grid of elements, ribs and splines, shaped as a reversal boat keel, with a horizontal vault crown (Fig. 2a). Generally, the ribs are composed by three parts, placed side by side, with variable sizes, nailed together. The rib curvature is conferred by connecting the layers of planks, upright arranged, with different length and inclination. The beam floors are composed by either single or double frames. In any case, the primary beams are generally stiffened by a supporting portal frame with a longitudinal beam set under the primary one and inclined struts. Above the planks a layer of lapilli and cement lime mortar is cast.

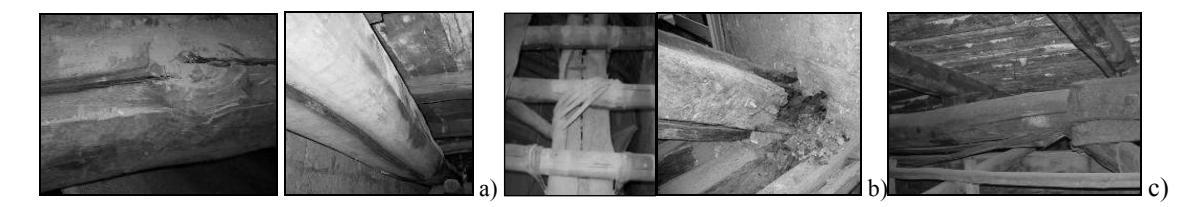
Figure 3. Failure diagnosis: a) Natural defects; b) Insect and fungi attacks; c) Bending overstress.

In situ diagnostic inspections were carried out in order to evidence the presence of natural defects, damage and decay situations (Fig. 3) and to characterize the elements as respect to the wooden species and mechanical properties by visual grading, according to the Italian codes UNI 11118 and 11119 (2004). The beam floors and the vault supporting structures are mainly made of chestnut, whereas the timber skeleton of the vault and the links are made of poplar.

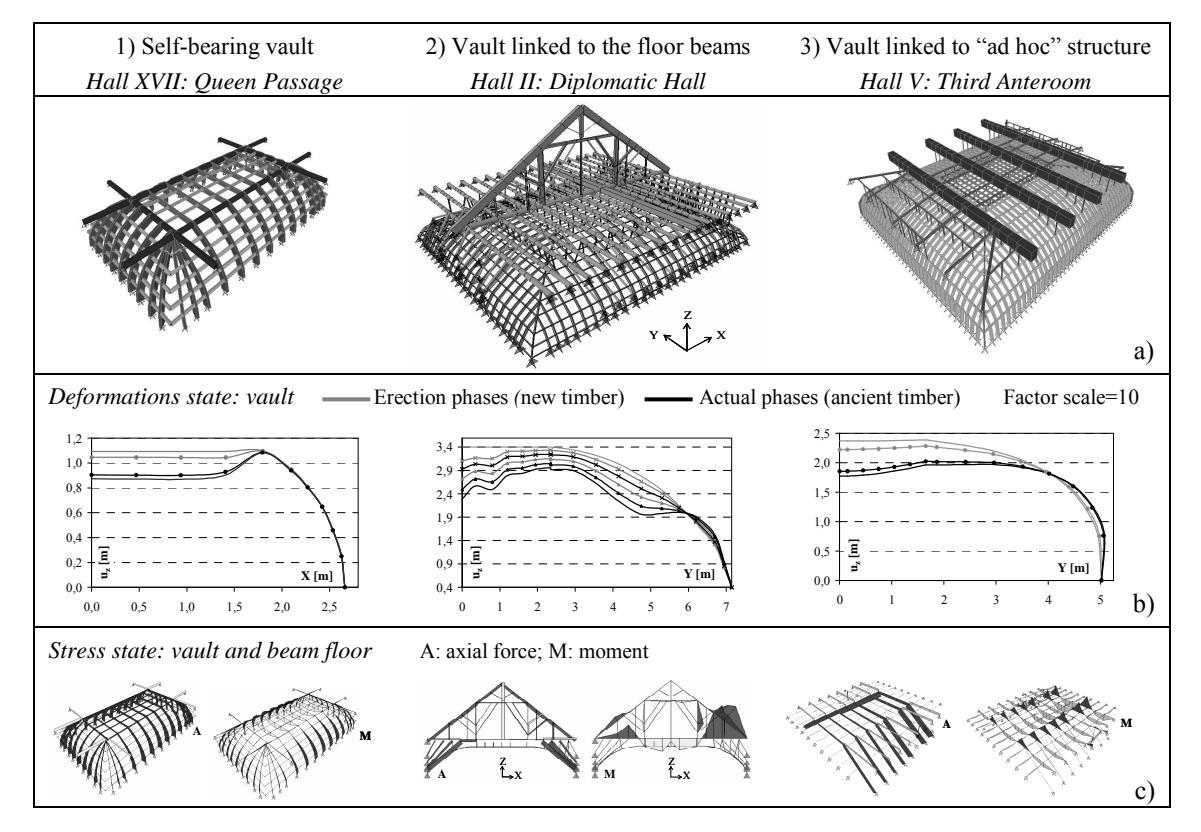
Figure 4. Examples of structural models and numerical analysis results: a) 3D FEM models; b) Deformation state; c) Stress state.

On the basis of the acquired knowledge of the structures obtained during the geometric and mechanical survey, 3D FEM models have been set-up by means of SAP 2000 v. 9.1.6 software, using frame elements (Fig. 4a), aiming at evaluating the bearing capacity of each structural component and its contribution to the behaviour of the whole structure (Mazzolani et al., 2010). In order to examine the stress and strain states during the whole life of the structure from the beginning until today, different load conditions have been analyzed, which the structure was supposed to have undergone, starting from the erection stages until the actual service condition. Concerning the mechanical characterization, for the structural models related to the erection phases of the structure the material has been modelled as "new timber", assuming the mechanical properties according to UNI 11035-2 (2003) standard. Besides, considering that the timber could be affected by working lacks and degradation, the material has been modelled as

The analysis of the structural behaviour has evidenced the weaknesses of the structure in terms of resistance and deformation capabilities (Fig. 4b,c). On the basis of the analysis results, appropriate restoration interventions have been conceived.

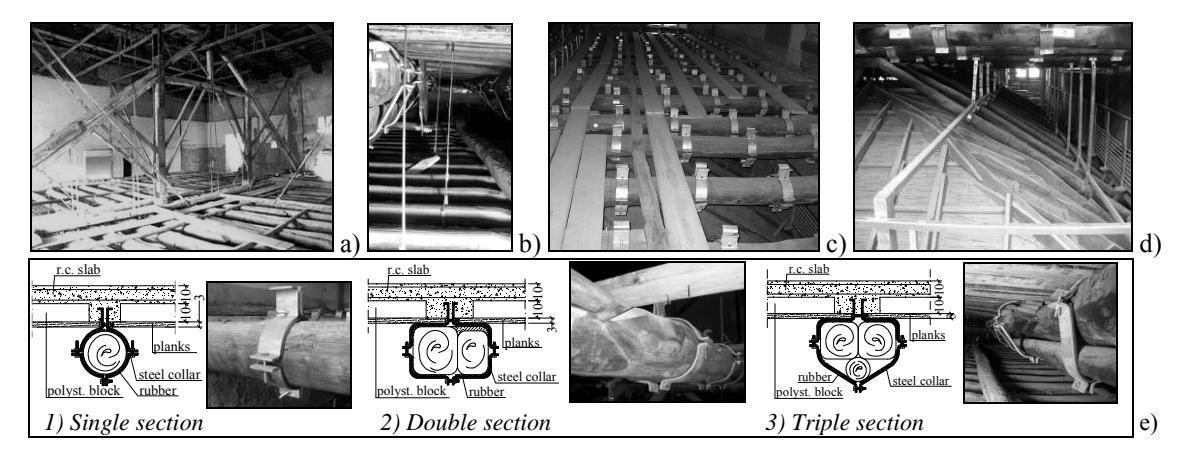
Figure 5. Global interventions a) Roofing structure before interventions; b) Vault-floor suspension; c) Beam-slab connectors installation; d) Stiffening systems for inclined struts; e) Collar types.

Appropriate restoration interventions were designed for the analyzed timber structures and realized for the complex roofing systems which cover the Diplomatic Hall (II) (Fig. 5a). They mainly consist in the optimization of the vault-floor connections, the upgrading of the whole structure, in terms of both stiffness and strength, by the realization of a steel-timber-concrete composite floor and the reduction of the inflection length of the buckled inclined struts. For the vault, all the struts links placed at the vault curved sides have been removed; while all the links at the horizontal vault crown have been replaced by steel cables (Fig. 5b). For the beam floor, a reinforced lightened concrete slab has been cast, it collaborating with the timber beams by means of steel connectors conceived with "ad hoc" shape (Fig. 5c). They are collars made of cold formed steel, each one composed by four parts bolted at appropriate folded wings (Faggiano et al., 2009). The superior ones have the function of connectors and are immersed in

the concrete cast. A layer of rubber is interposed between the collar and the timber element, in order to assure the adaptability of the system to the irregular surface of the existing ancient beams. The friction at the timber-steel surface is guaranteed by the bolt tightening force, which also provides a transversal ringing action on the beam. Three types of connectors have been installed, depending on the particular shape of the beam cross-section (Fig. 5e). The reinforcement of the unstable inclined struts were realized by means of both horizontal and vertical stiffening elements (Fig. 5d). At the longitudinal and transversal struts a steel vertical element is bolted at both ends, to the beam collar connector above and to the struts collar below, in order to stiffen the struts in the vertical plane. Furthermore, tubular horizontal steel profiles connect the struts at the collar and to the perimeter masonries, in order to stiffen the struts in the horizontal plane.

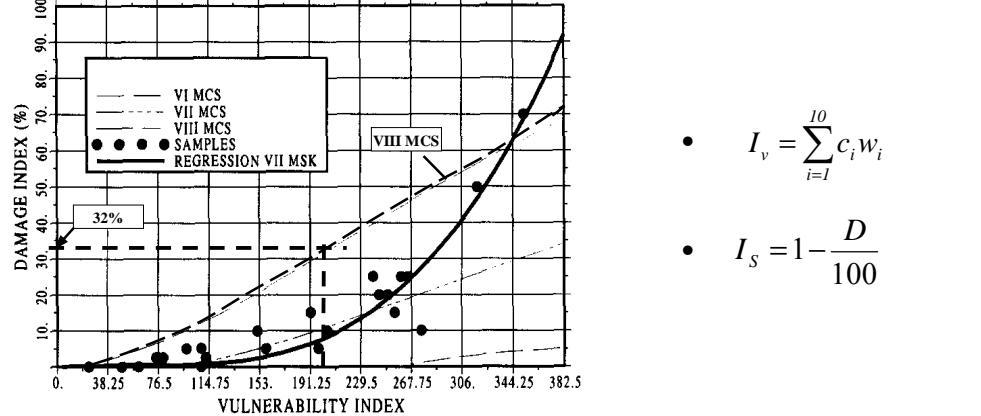
Table 1. Parameters for the calculation of the vulnerability I_{ν} , damage D and safety indexes I_S

With reference to the North-West wing of the Royal Palace the ten reference parameters were evaluated, based on the detailed survey carried out (geometrical and mechanical) and the evidenced conservation state of both structures and completion elements. The score and the weight related to each parameter are summarized in Table 1, where the values attributed to the building under study are plotted in bold characters. It is worth noticing that as far as the score is large (from A to D) the class is worst. In the same Table the (I_v , D) relationships are drawn.

associated to each class and the corresponding weight factor, is equal to 206.25, such as 53% of maximum possible value 385.5 (Mazzolani et al. 2008). The damage index D is equal to about 32 %, with reference to the most sever VIII MCS intensity, selected for the sake of safety. Therefore, the safety index I_s is equal to 0.68 (Mazzolani et al. 2009), which evidences a medium seismic vulnerability of the analyzed building.
