## Distributed Fiber Optics Monitoring of the Lago Bianco Dam in Switzerland

Tiziano CRAMERI<sup>1</sup>, Alessio HÖTTGES<sup>2</sup>, Carlo RABAIOTTI<sup>2</sup>

<sup>1</sup> Repower, Poschiavo, Switzerland

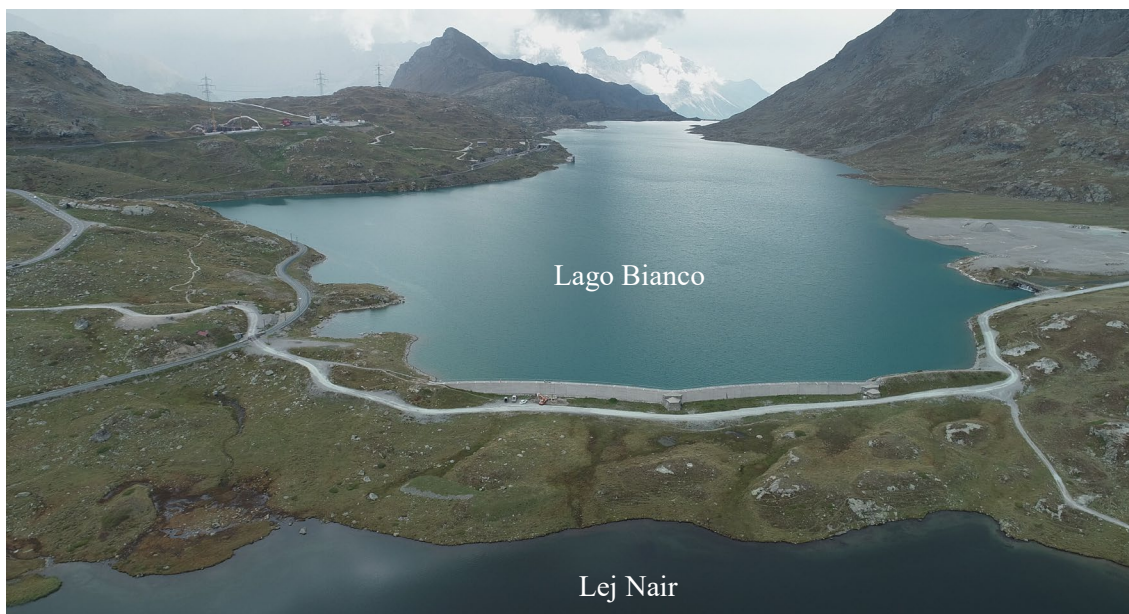
Figure 1. Lago Bianco Dam

The northern dam of the Lago Bianco (2'235 m a.s.l.) is a gravity wall and consists of three interconnected arches with lengths of 75 m, 95 m, and 110 m respectively (Figure 1). The DFOS were installed on the centre part of the eastern arch in close proximity to the existing monitoring system, which includes two extensometers, one joint meter, one piezometer and five thermocouples inside the structure. The DFOS were fixed on the downstream side of the dam on a grid carved into the dam surface (see Figure 2).

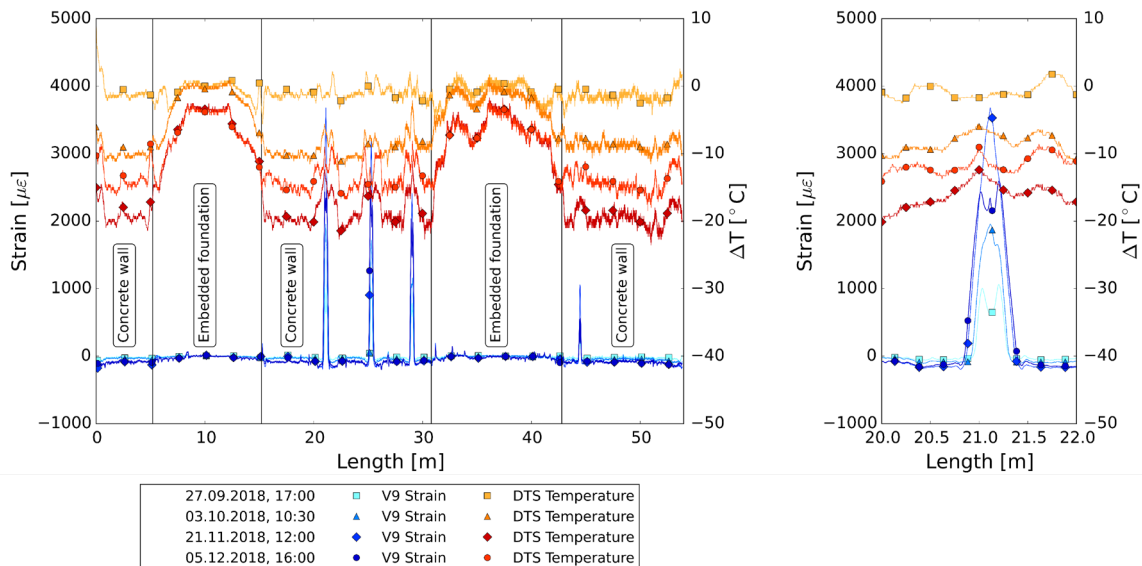
Figure 4 illustrates superimposed the variations of the temperature and strain in different periods and positions on the dam surface. The temperature in the embedded part of the foundation is relatively stable; this is due to thermal insulation of the earth covering.

Figure 4. Superposition of temperature and strain measure for different periods. Right: detail of the crack

On the contrary, the portion of the DFOS installed in the concrete wall, directly exposed to air, shows a pronounced decreasing trend. Another important observation is that the strain peaks (clearly caused by the cracks) can also be identified in the DTS sensor cable in the same location (Figure 4). The fibers in the DTS sensor cables may begin to stretch as well when the cables undergo large deformations, thus becoming strain sensitive. This effect was already observed during preliminary laboratory tests as well as by other authors (Hauswirth, 2015). Nevertheless, this influence can be neglected for small strains as demonstrated by (Klar & Linker, 2010).

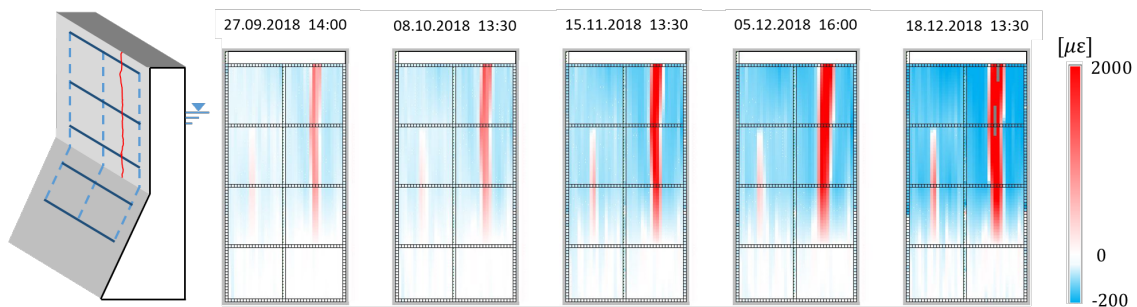
Figure 5. Horizontal strain field on the downstream face of the dam's wall

Figure 5 represents the evolution of the strain field along the dam's wall in different periods. The reference measurement was carried out the 21<sup>st</sup> of September.

The DFOS measurements are additionally linearly interpolated over the entire surface in order to obtain the two-dimensional strain field. The regions coloured blue correspond to compressive strain (negative) while the red ones represent tensile (positive) strain. The location of the vertical crack along the dam's wall, represented by the red coloured region, can clearly be observed. The visual inspection confirms the location of the crack in this position. The crack's strain peak increases during winter due to the decreasing temperatures, meaning that the crack is widening

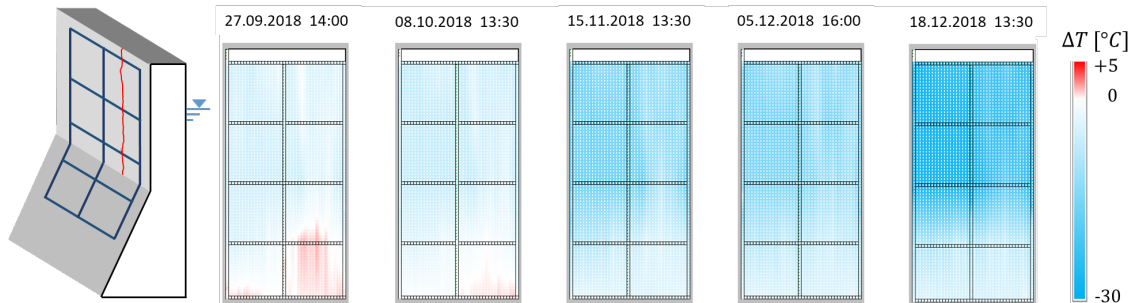
Figure 6. Temperature variation on the dam's downstream surface.

due to a shrinkage of the dam's wall. The temperature variation on the downstream surface of the wall is shown in figure 6. The reference zero measurement was taken the 21<sup>st</sup> of September.

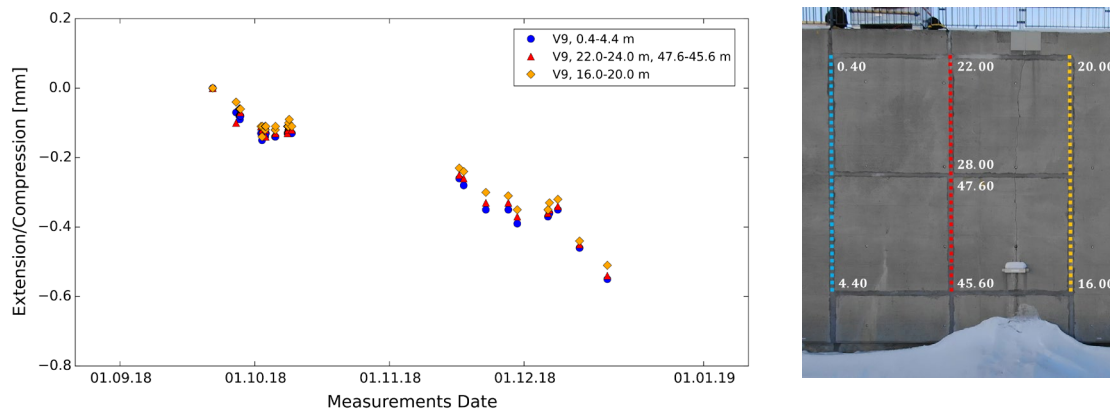
Figure 7 (left) shows the vertical extension/compression of the dam wall for three segments of the cable, each 4 m long (Figure 7, right). The results are obtained from the integration of the strains. It can be observed that:

- The compressive deformations increase with decreasing temperatures in winter
- In October measurements have been carried out with a regular schedule during the day. In this month the thermal gradient during the day is the highest. Based on these results, it can be concluded that the effect of temperature change during the day is neglectable

Figure 7: Vertical extension and compression of the dam wall (left), portion of the integrated cable (right)

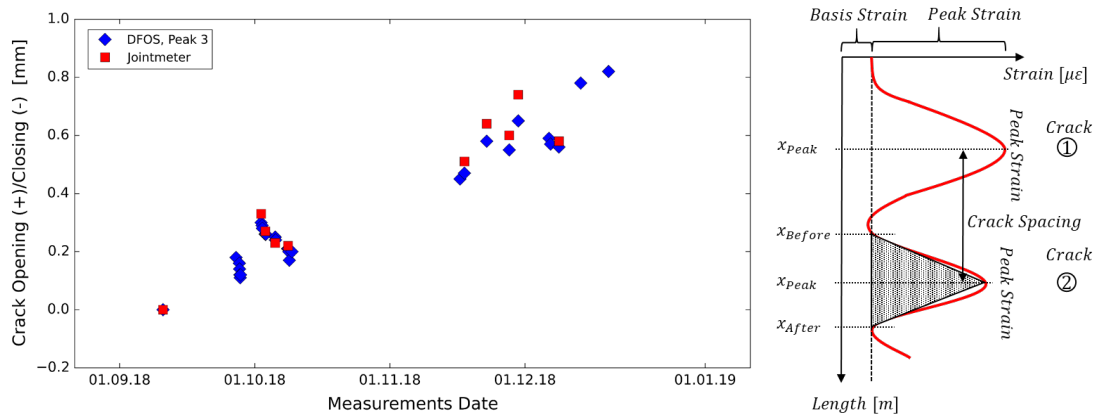
Figure 8 shows the crack openings measured with the joint-meter and with the DFOS for different periods. The trend of opening cracks with decreasing temperatures can clearly be observed. A very good agreement between the two measuring system is shown.

Figure 8: Comparison between the crack width from DFOS and the joint-meter (left), graphical representation of the crack's width calculation procedure (right)

The main vertical crack in the dam surface is monitored by a joint-meter. The effects of the crack are also clearly visible with the DFOS strain sensor, where very large strains, higher than 2'000 microstrains, are measured (Figure 8, left). A simplified method is adopted in this paper to estimate the crack width from the DFOS measurement. In general the distance between the peaks in the strain measurement can be considered as the crack spacing. The crack width can be assessed integrating the tensile strain distribution on both sides of the peak (grey triangle in Figure 8, right). Obviously the crack width is much smaller than the region where tensile strains are measured: the cable is stretched in an area wider than the crack. This lead to the conclusion that the effects of the crack propagate for some cm in the mortar embedded part of the DFOS sensor cable. On one hand, this prevents the DFOS from breaking, on the other the tensile strains are mainly due to the crack opening. Therefore, if the tensile strains are integrated over the representative length, the crack width can be obtained.
